Final Report on:

Dogwood Drive
CCTV Inspection of Existing 48" & 72" Storm Drain
Between Country Lane and Pipe Outfall

Vista Design, Inc.
11634 Worcester Highway
Showell, MD 21862

April 20, 2010

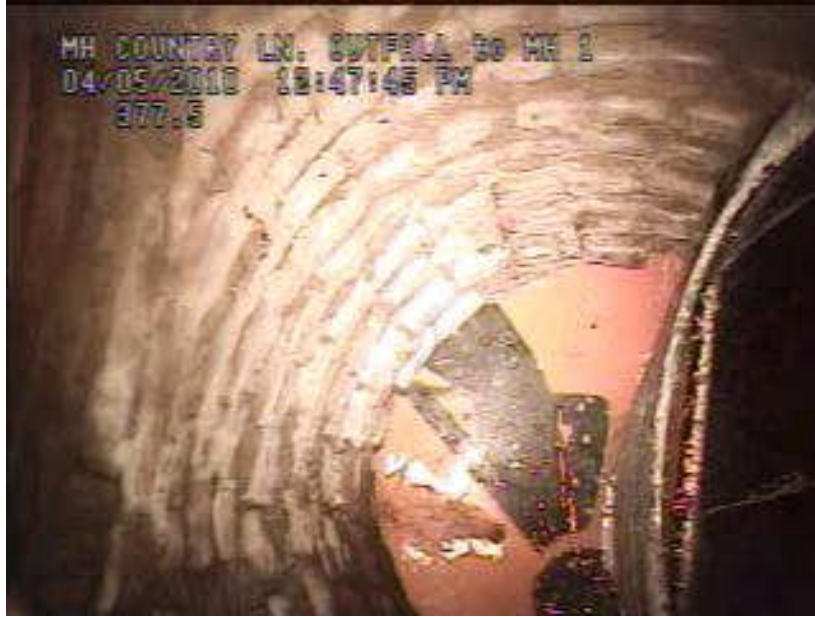
Following the sequence of inspection depicted by the VDS videos, beginning at manhole 1 and proceeding in a southerly direction, most of the 48" CMP appears to be in fairly good condition. Minor corrosion was observed at several pipe junctions and minor debris was noted in several locations. A buried manhole was identified at the 378' mark, along with an inflowing CMP section from the east (Appendix C, Photo 1).

Photo 1 – 48” CMP – Buried Manhole

Based on a review of the VPS videos, the 48” CMP and 48” RCP sections of the Dogwood Drive pipe network appear to be in relatively good condition and can be expected to perform properly following removal of accumulated debris and sedimentation. It is recommended, however, that the buried manhole be uncovered and a proper top and lid installed to ensure usability of this access point. These corrective measures are not critical in nature, but given the fact that the sediment and debris are limiting the conveyance capacity of the pipes, maintenance should be undertaken as soon as possible to restore the original pipe capacity and avoid flooding of upstream areas during large storm events.

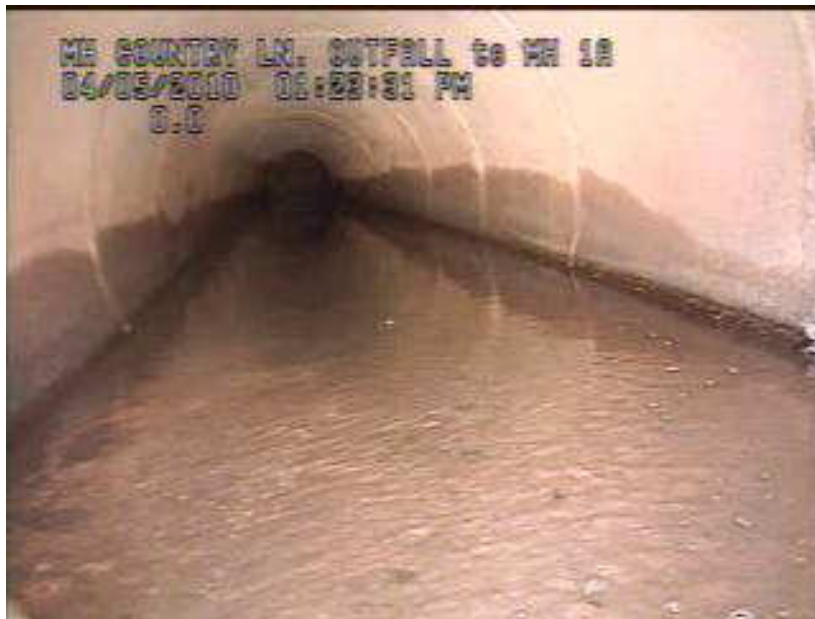
Beginning at the inflow point of the 48" RCP and proceeding in a northerly direction, the inspection revealed the RCP pipe to be in good physical condition. The bottom of the pipe appears to contain light to moderate sedimentation, and given the fact that the base flow in the pipe deepened as it approached the buried manhole (at which point the pipe material transitions to CMP) it is possible that the pipe is not properly aligned as it enters the buried manhole. However, the base flow made thorough reconnaissance of conditions impossible and results inconclusive (Appendix C, Photo 2).

Photo 2 – 48” RCP

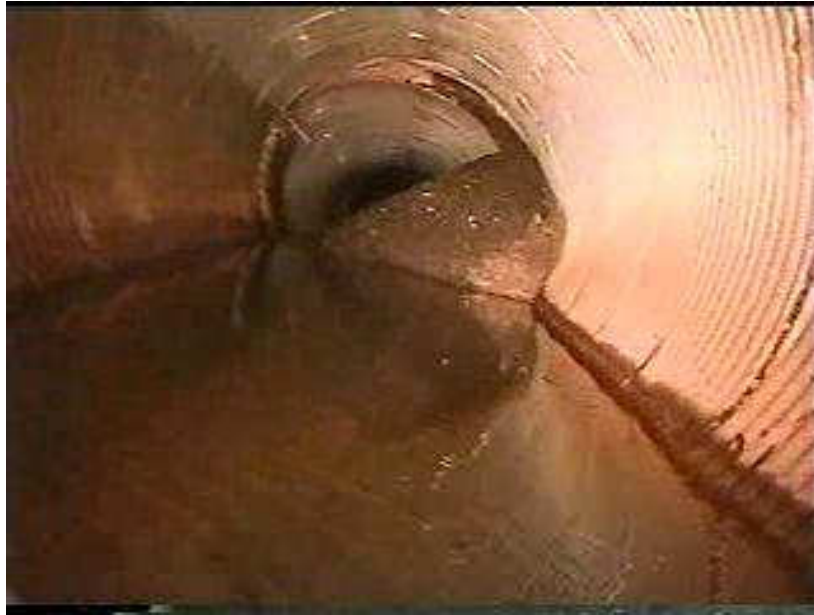
- The 72" pipe has been compromised at a location approximately 20' below manhole 2. The cause of the breach has not yet been determined due to the massive amount of sediment accumulated within the pipe at this location, but it appears that the entire east side wall of the pipe has failed, thus allowing soil to enter. If the eastern wall of the pipe has indeed failed, the entire pipe section will be unstable and subject to failure. At a minimum, the sediment at this location is blocking over 60% of the pipe's conveyance capacity.

Beginning at manhole 2 and proceeding in a northerly direction, the 72" CMP at first appears to be unobstructed. However, 20' downstream, a large pile of sediment along the eastern wall of the pipe indicates that the pipe has been compromised. Based on the inspection video, the pipe appears to be over 60-percent obstructed, however the accumulated debris and sediment make it impossible to determine the full extent of the pipe breach. Nevertheless, the massive amounts of sedimentation in the pipe and the location of such sedimentation along the pipe's eastern wall indicate the breach to be of sufficient size to jeopardize the structural capacity of the pipe (Appendix C, Photo 3). Inasmuch as, this section of pipe is situated beneath an existing driveway, immediate corrective measures are recommended to ensure that additional soils do not wash into the pipe further undermining the driveway, which could collapse, potentially resulting in property damage and/or personal injury.

Photo 3 – 72” CMP – Breach 20’ Downstream of MH 2

The 72” CMP, however, is in need of immediate attention. The two large breach areas are located immediately beneath private driveways, which appear to be used on a daily basis. Considering the size of both breaches, should no corrective actions be implemented, sink holes, additional pipe sedimentation and ultimately full network failure are probable. At a minimum, the two breach areas should be immediately repaired through the removal and replacement of the affected pipe sections. However, this will not address the many pipe joint separations or heavily corroded areas that are present along the length of the pipe, which will only worsen with time. The only methods to fully correct the pipe deficiencies are either through removal and replacement of the entire 72” pipe section, or through the selective removal and replacement of the breached sections and linings of the entire pipe length with Cured-in-Place-Pipe (CIPP) technologies.

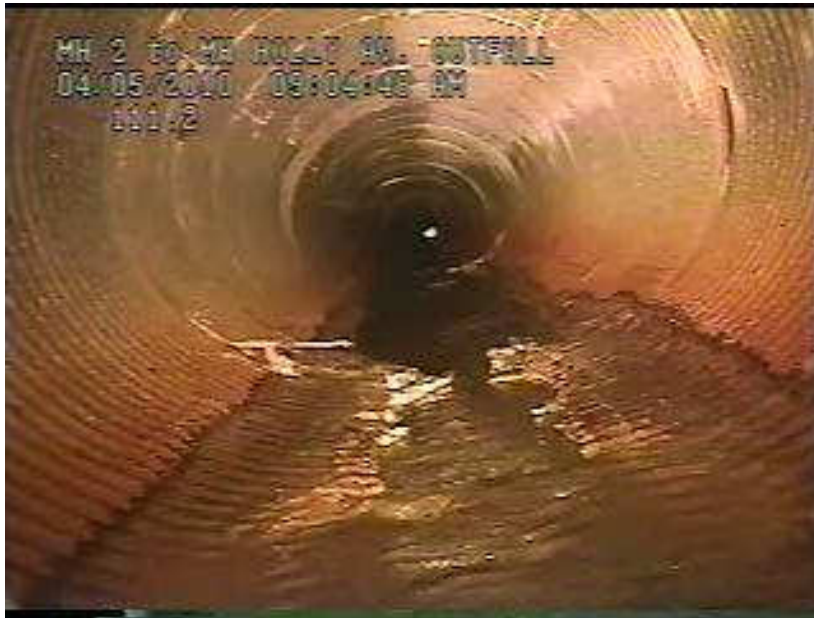
Continuing downstream in the 72" CMP, multiple areas of pipe joint separation were identified, which are currently allowing sediment and debris to enter the pipe network and undermine the surrounding areas. Heavy debris was also identified in this section of the pipe, as well as large sections of corroded pipe bottom.

Photo 4 – 72” CMP – Corrosion of Pipe Bottom (typical)

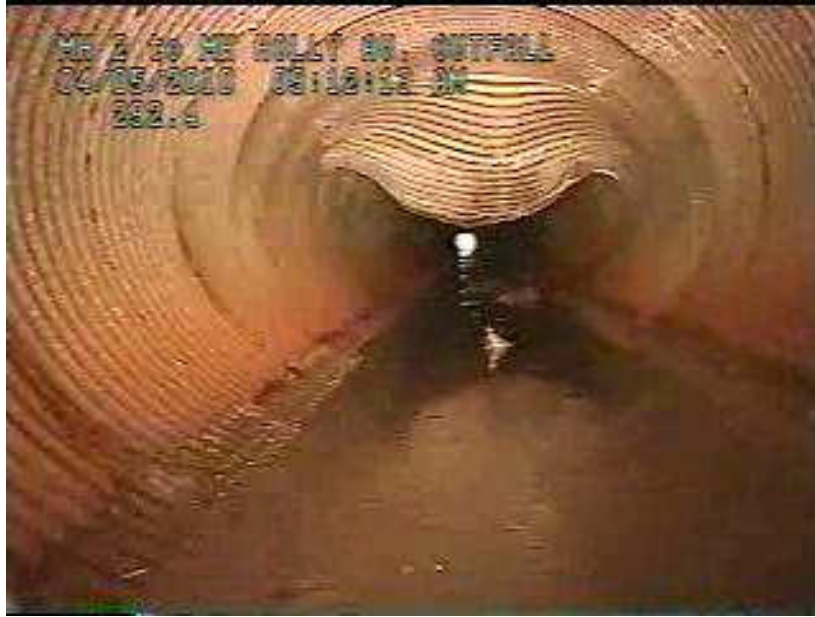
- The 72" pipe has been compromised at a location approximately 308' below manhole 2. Based on the video images, it appears the pipe has collapsed from above and may have also separated from the adjacent pipe section, given the large amount of seepage shown entering the pipe from the top at this area (although the video images do not clearly indicate if the pipe sections are actually separated or just collapsed). The degree of pipe collapse is significant enough to jeopardize the structural stability of the pipe, thus making it subject to failure. At a minimum, the collapsed pipe is blocking over 50% of the pipe's conveyance capacity.

At a point approximately 308' downstream of manhole 2, the 72" pipe appears to have collapsed from above (Appendix C, Photo 5). The inspection video does not provide sufficient detail to determine if the collapse occurred at a joint (i.e. – pipe separation) or mid-pipe (i.e. - pipe deflection), but since infiltration was visible from above the pipe, one can reasonably conclude that it is at least partially breached. Whereas, this section of pipe is located directly beneath an existing driveway and appears to be unstable, immediate corrective measures are recommended to ensure that additional soils do not wash into the pipe and further undermine the driveway, which could collapse, resulting in property damage and/or personal injury.

Photo 5 – 72” CMP – Pipe Breach 308’ Downstream of MH 2

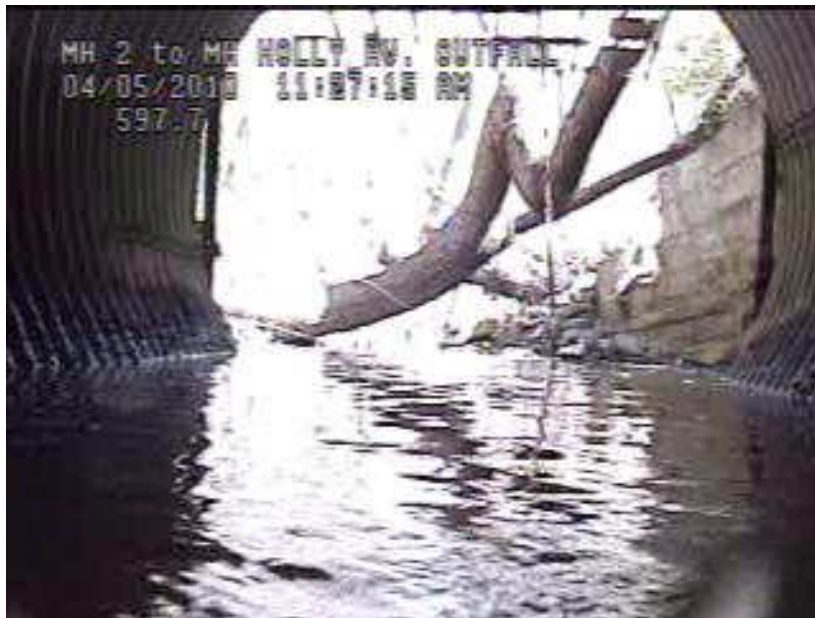
- The outfall of the 72" CMP contains heavy debris, which is limiting the conveyance capacity of the entire system. However, once this debris is removed, the pipe velocities will likely be sufficient to significantly erode the adjacent stream valley.

Continuing downstream, the inspection reveals additional pipe joint separations and areas of pipe corrosion and heavy debris in the 72" CMP. The outfall of the pipe also contains heavy debris, which is severely impacting the conveyance capacity of the pipe.

Photo 6 – 72” CMP – Pipe Outfall

In either case, VDI suggests that an energy dissipater be designed for the outfall of the 72" pipe to reduce outfall velocities prior to discharge into the adjacent stream valley, thereby mitigating stream valley erosion.
