**MUNICIPAL SEPARATE STORM SEWER SYSTEM  
DISCHARGE PERMIT NUMBER: MD0068365  
STATE DISCHARGE NUMBER: 11-DP-3322**

**CHARLES COUNTY, MD  
ANNUAL REPORT  
JULY 2021 - JUNE 2022**

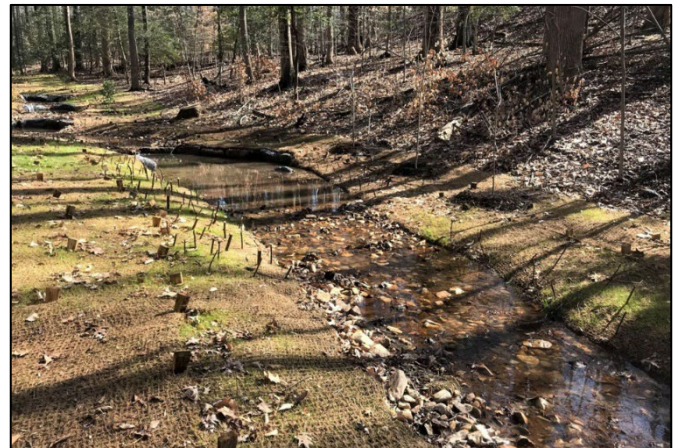
*Approx. cost per acre treated: \$45,325*

*Status: Construction Complete March 2020*

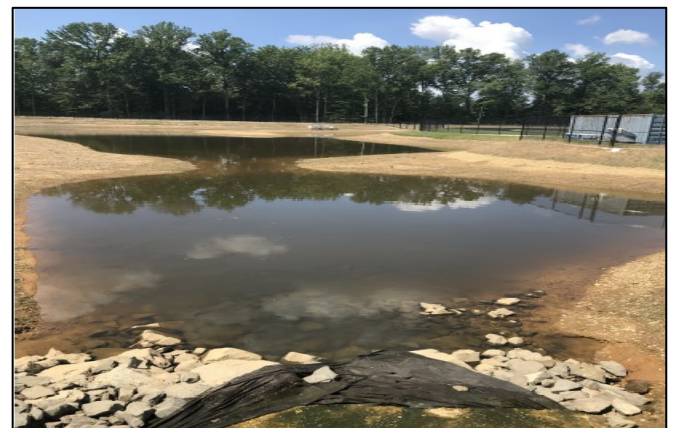
#### ***LaPlata High School Stormwater Retrofit***

*Approx. cost per acre treated: \$27,368*

*Status: Construction Complete May 2020*

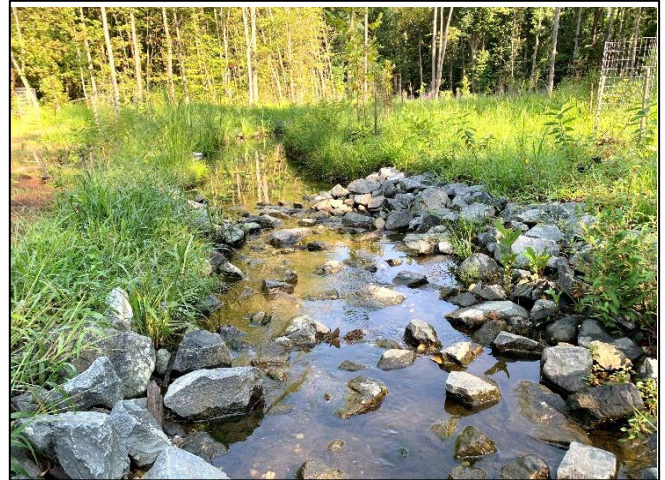
**St. Charles Parkway Stream Restoration**  
(County Permit # VCI 170053)

Design completed August 2019.  
Construction began December 2019.

*Approx. cost per acre treated: \$115,521*

*Status: Construction Completed June 2020*

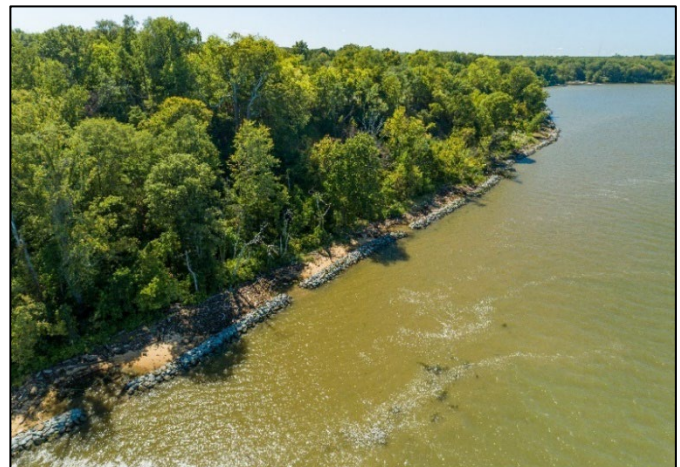
*Approx. cost per acre treated: \$21,621*

*Status: Construction Complete June 2020*

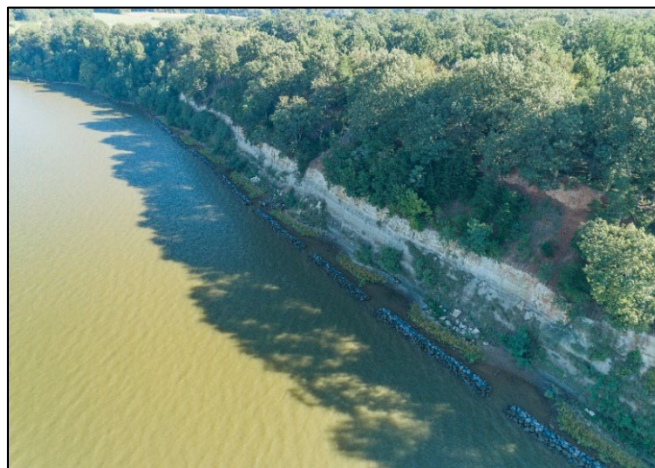
**Clifton Shoreline Stabilization Phase 1&2**

*Approx. cost per acre treated: \$17,437*

*Status: Construction Complete July 2020*

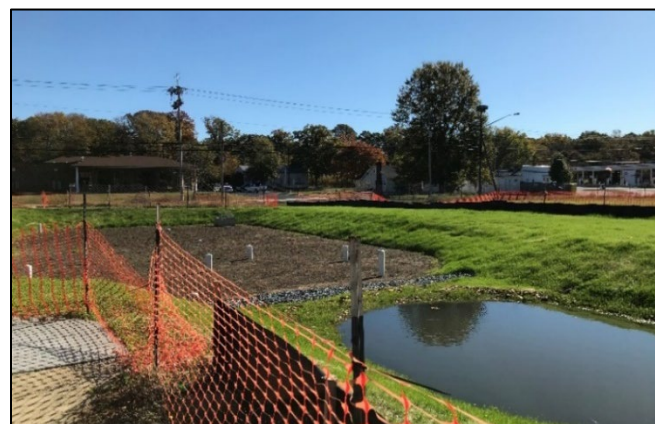
**General Smallwood Middle School**

*Approx. cost per acre treated: \$108,814*

*Status: Construction Complete September 2020*

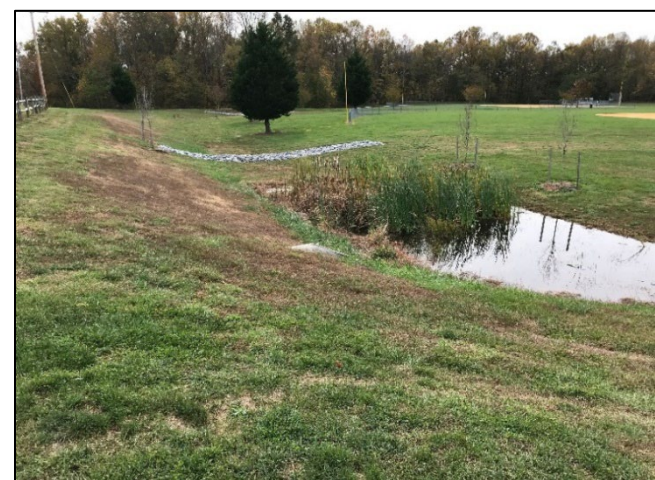
**Bensville Park Stormwater Retrofits and Tree Planting**

*Approx. cost per acre treated: \$54,105*

*Status: Construction Complete November 2020*

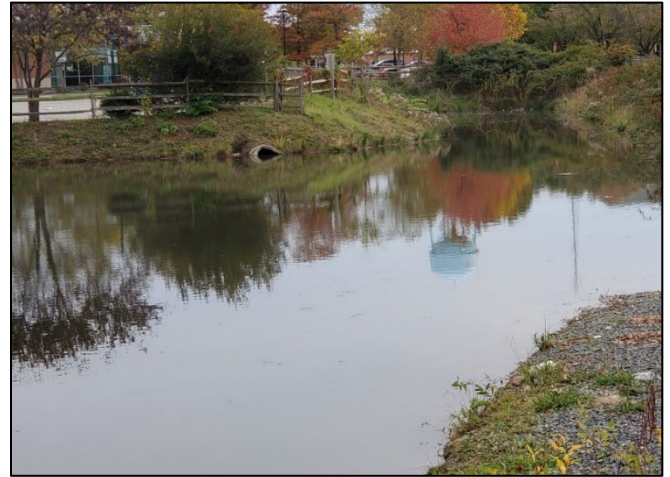
**Best Buy Stormwater Pond Retrofit**  
(County Permit # DSP 190036)

Design completed April 2019.  
Construction began June 2020

*Approx. cost per acre treated: \$70,671*

*Status: Construction Complete May 2021*

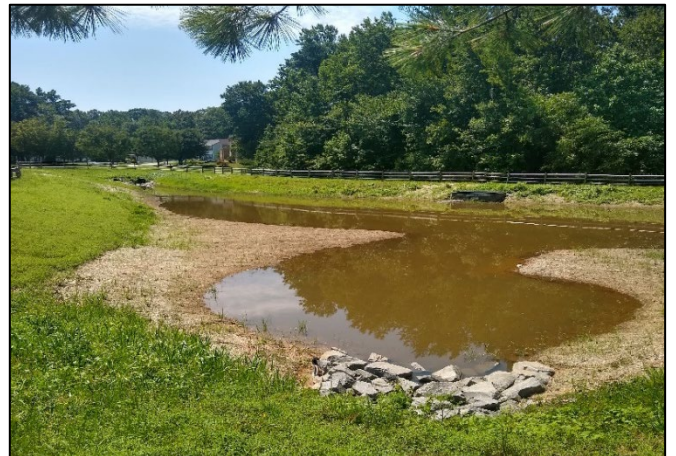
**Cedar Tree Stormwater Pond Retrofit**  
(County Permit # DSP 190047)

Design completed April 2019.  
Construction began June 2020

*Approx. cost per acre treated: \$51,271*

*Status: Construction Complete June 2021*

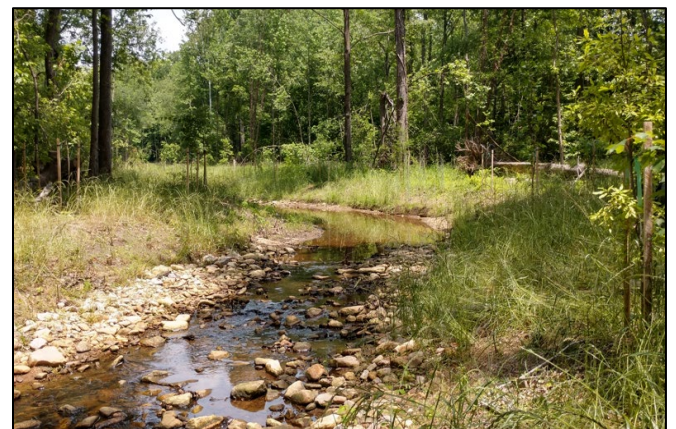
**Ruth B. Swann Main Channel Stream Restoration**  
(County Permit # DSP 190020)

Design completed September 2019  
Construction began December 2020

*Approx. cost per acre treated: \$12,750*

*Status: Construction Ongoing*

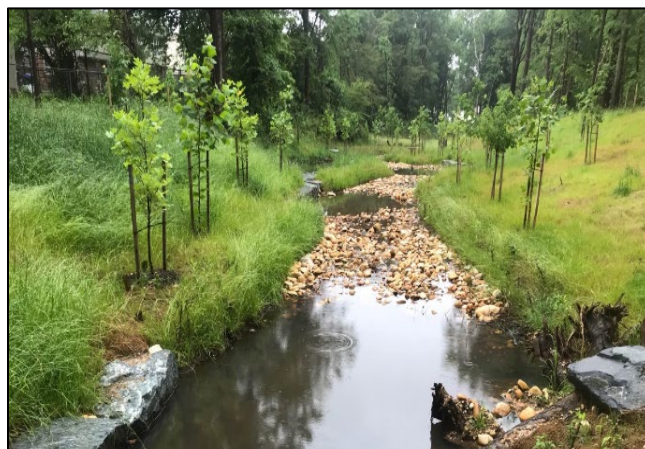
***Hunt Club/Bridle Path Stream Restoration***

*Approx. cost per acre treated: \$14,260*

*Status: Construction Ongoing*

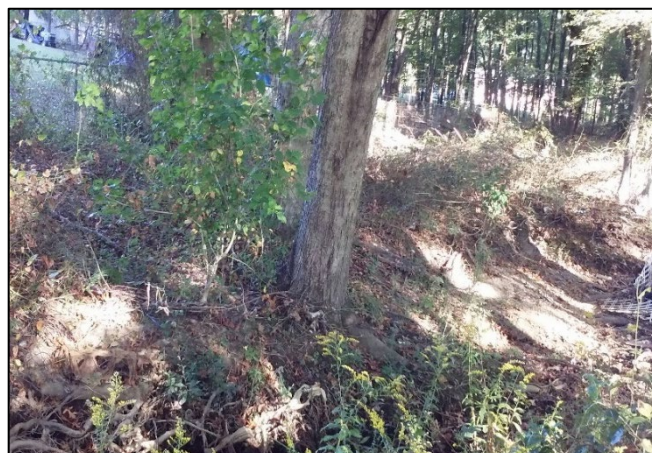
***Marbella Subdivision Stream Restoration and Outfall Stabilizations***

*Approx. cost per acre treated: \$40,760*

*Status: Preparing Bid Documents*

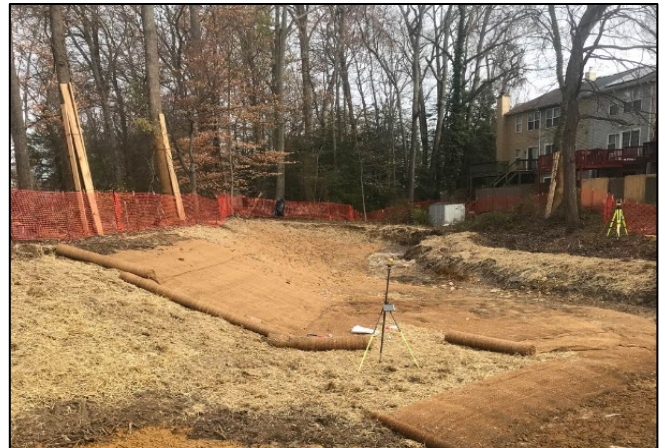
***CSM Tributary Stream Restoration***

*Approx. cost per acre treated: \$84,150*

*Status: Construction Ongoing*

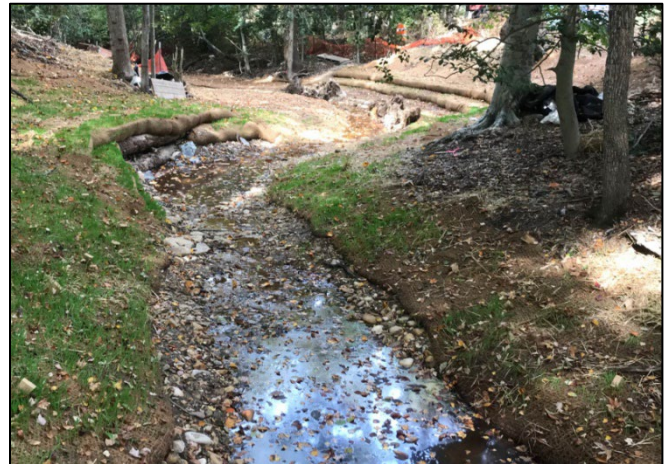
**Ruth B. Swann Tributary Restoration**

*Approx. cost per acre treated: \$54,330*

*Status: Construction Ongoing*

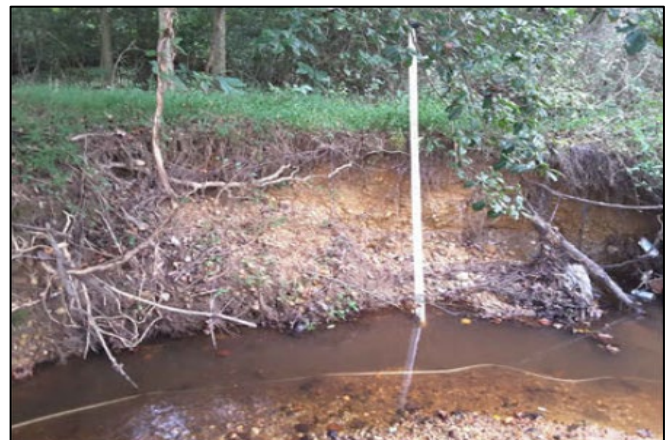
**Ruth B. Swann Upper Stream Restoration**

*Approx. cost per acre treated: \$21,738*

*Status: Construction Ongoing*

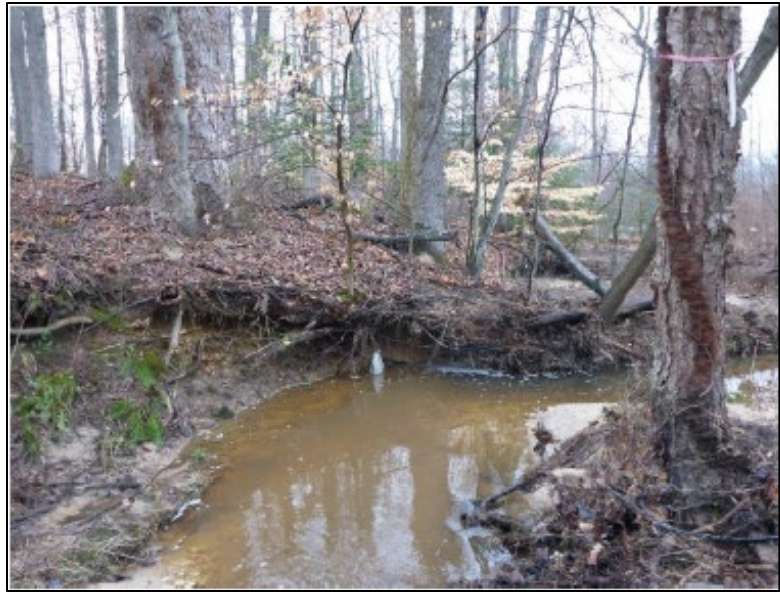
Downstream of Cross Section 1, however, all beaver dams and remnant dams had been washed out in 2018, likely as a result of the significant storm on February 10-11<sup>th</sup>, 2018. While evidence of flows having accessed the floodplain were noted throughout the study area in 2018 to 2020, major changes were noted downstream of Cross Section 1 in 2018. A large headcut was present near station 4+00 and the channel had downcut through areas that were previously backwatered by beaver dams, leaving an incised single-threaded channel with bank erosion present in places. In 2019 the headcut seemed to have stabilized and no other major changes were noted, but the channel will likely continue to change in response to the new stream flow regime unless the beaver dams are rebuilt. In 2020 the channel appeared to degrade downstream of Cross Section 1. It is likely that fine sediment deposited while the beaver dams were backwatering this part of the reach are continuing to wash out. In 2022, the abandoned beaver dam that had blown out in 2021, remains stable with only a slight increase in cross sectional area from 2021 to 2022. The channel remains abandoned through Cross Section 1 due to the channel cutting around the large beaver dam upstream of Cross Section 1 and forming a new main channel through the floodplain.

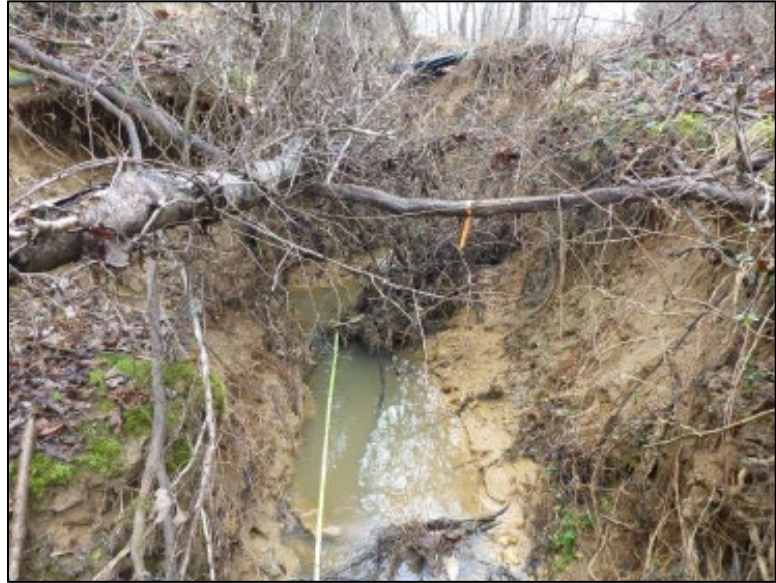
2+92 to 2+87) and the drop increased to 5.5 feet. In 2020 and 2021 the headcut did not move significantly further upstream and the total drop remained similar, but additional erosion of bed material created a step in the formerly undercut headcut. In 2022, the previously eroded step in the headcut was gone, creating one large drop, but the headcut remained in the same location from 2021 to 2022. Beaver dams were noted throughout the North Point Tributary which is new for 2022. Cross Sections 1 and 2 remain stable and no significant changes were noted other than increased water surface levels from the backwatering effects of the beaver dams. Cross Section 3 saw a change in shape as it has lost the inset channel in the floodplain that was made up of fine sediment deposition, which was first noted in 2013. This feature is likely gone due to a beaver dam constructed downstream that has backed water up.
