WICOMICO RIVER

WATERSHED ASSESSMENT

MAY | 2018

KCI TECHNOLOGIES, INC.
936 RIDGEBROOK ROAD
SPARKS, MD 21152

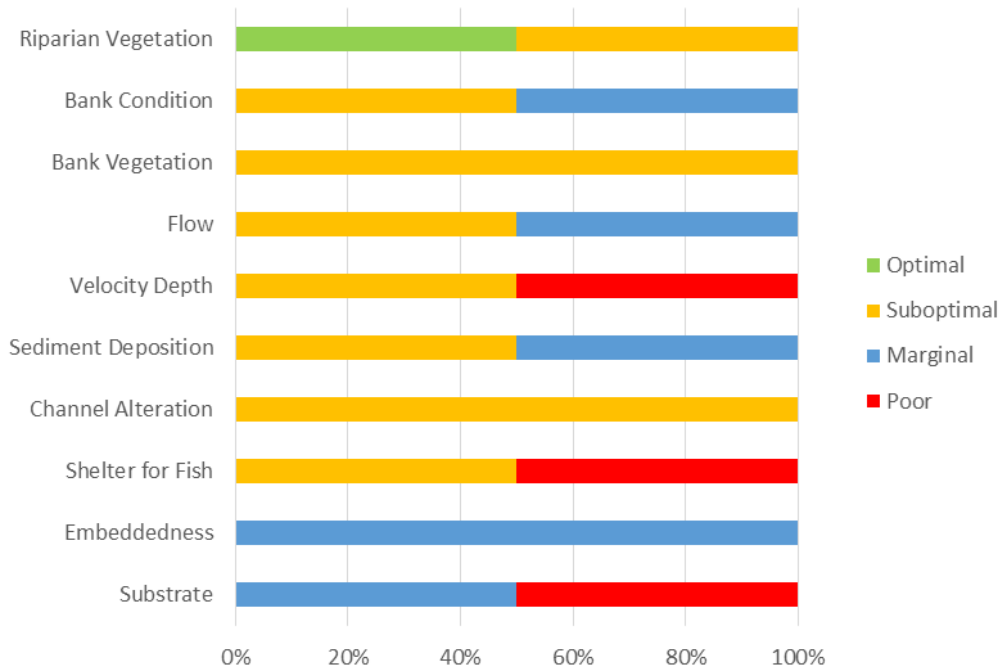
FIGURE 12: PROPORTION OF REACHES PER ASSESSMENT CATEGORY

Representative points were taken at two locations (Figure 11). Figure 12, below, presents the proportion of reaches in each assessment category for each habitat parameter, giving insight into the types of stream impacts creating the most degradation. In general, the modified qualitative RBP assessment at these sites revealed stream channels dominated by gravel substrates. One site (R06_RE01) received scores of “marginal” and “suboptimal” for all parameters. Site R06_R02 received “poor” scores for benthic substrate, shelter for fish, and velocity/depth diversity and all other parameters received scores of “marginal” or “suboptimal”.

Stream channel erosion is a major factor leading to impaired habitat conditions. The majority of the identified erosion sites (76%) were described as channel widening processes. As the stream channels widen, the ability to effectively transport sediments (eroded bank material and from runoff over land) is reduced, leading to reduced scores for several habitat parameters including flow, velocity, embeddedness and macroinvertebrate habitat.

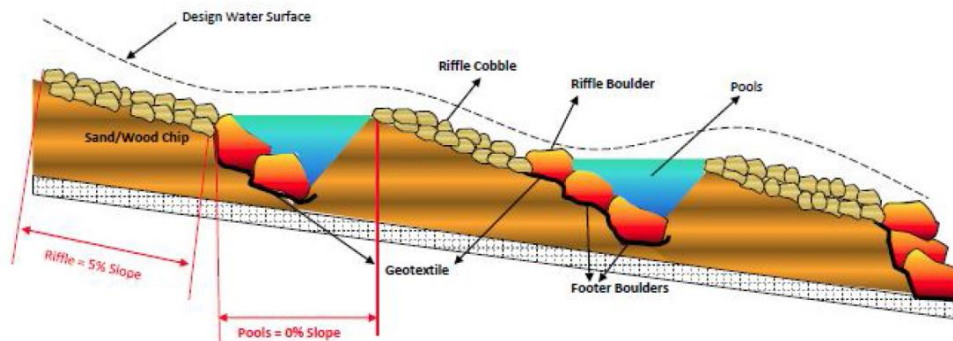
An SPSC system consists of alternating pools and riffle channels. The length of the pools is typically twice the length of the riffles and a minimum of 18 inches deep. The maximum length of the riffle structures is typically eight feet so as not to build excessive energy. Also, an SPSC segment used for water quality should not exceed 5% in longitudinal slope. If the overall slope exceeds five percent, boulder cascades may be utilized to traverse the grade. All unarmored sides of the pool are laid at no steeper than 3H:1V. In the event the connecting stream is incised, boulders are used to construct an in-stream weir.

Profile for Regenerative Stormwater Conveyance System (source: Anne Arundel County, 2011)

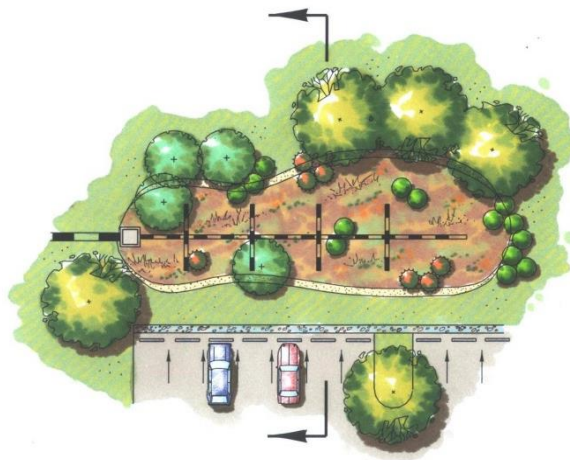
Bioretention areas generally consist of a stone diaphragm, filter fabric, filter media, landscaping, and an underdrain system. The stone diaphragm reduces the velocity of the runoff from the impervious surface that is entering the facility and also removes suspended material that may clog the filter media. The underdrain system is a perforated pipe system that collects the water that has filtered through the permeable media and transports it to a downstream open channel or connects into a nearby storm drain.

Plan view of bioretention area
