**FINAL**  
**ASSESSMENT AND**  
**SHORELINE MANAGEMENT PLAN**  
**FOR REACHING NPDES MUNICIPAL SEPARATE STORM**  
**SEWER SYSTEM PERMIT (MS4) GOALS**  
**FOR**  
**CHARLES COUNTY, MARYLAND**

**September 2018**

SOUTHERN MARYLAND  
RESOURCE CONSERVATION AND DEVELOPMENT  
(RC&D)

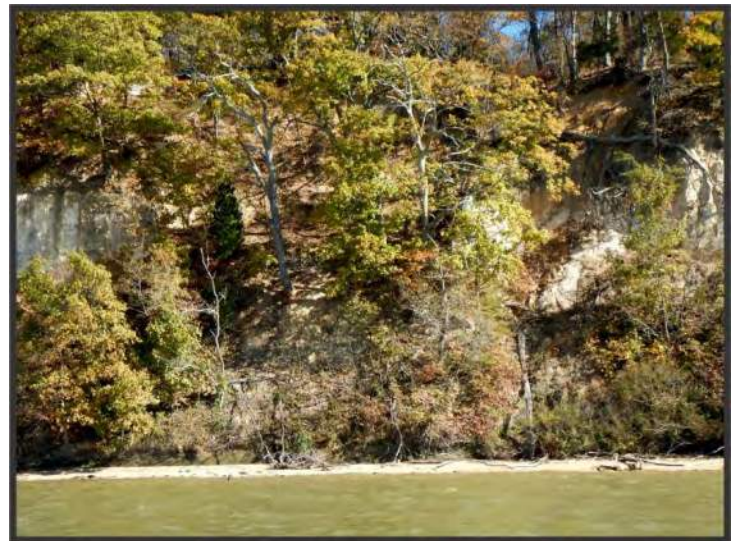
Figure 2-3. Sloughed/slumped material along a high bank. The material protects the base of bank until it erodes.

Along the Charles County coast, the primary forces of geomorphic change are the undermining action of waves against the base of the banks (Figure 2-3). The bank face becomes too steep to support the load and fails by sloughing/slumping. For some time, the bank is stable where the sloughed material sits along the shore. However, the sloughed material is continually acted upon by the ongoing wave action and, with time, will erode back to the in-situ bank, and the process begins again. Other factors such as upland runoff, freeze/thaw, and groundwater can add to bank instability but are not major factors along Charles County's coast.

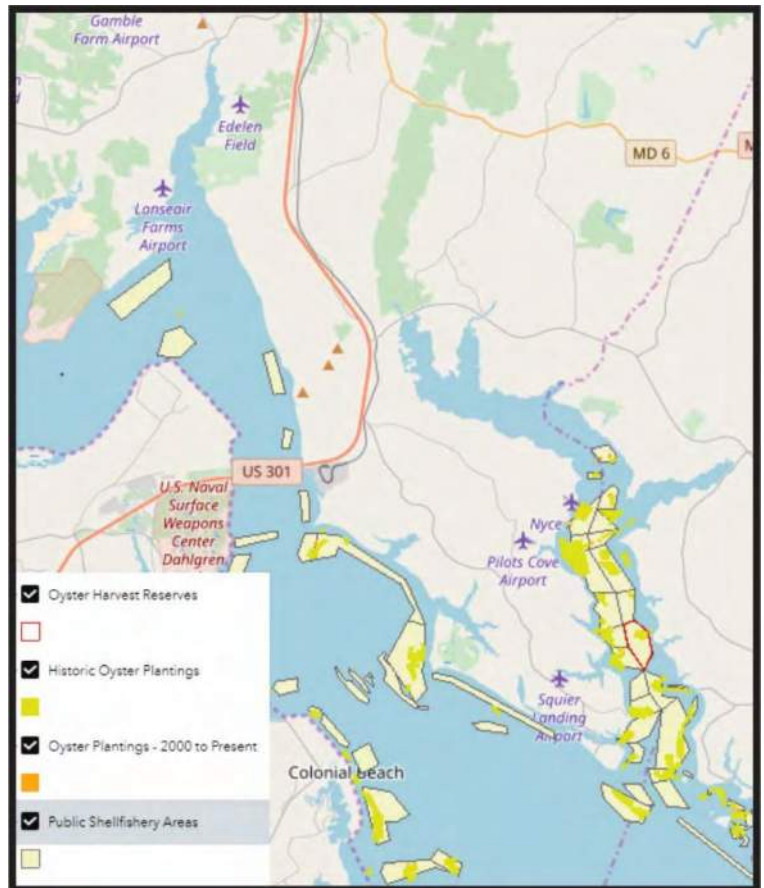
Figure 2-5. Oyster leases in the Charles County. From Maryland Coastal Atlas, <https://gisapps.dnr.state.md.us/coastalatlus/WAB2/>

Oyster bed leases are mostly found in the Wicomico River and in the adjacent Potomac River (Figure 2-5). The historic leases are show in off-white in the figure. These are the sites that have historically been fished. The yellow data indicate oyster plantings that took place in the 1980s and 1990s. The orange data, that does show up well on the figure depicts oyster plantings from 2000-present.

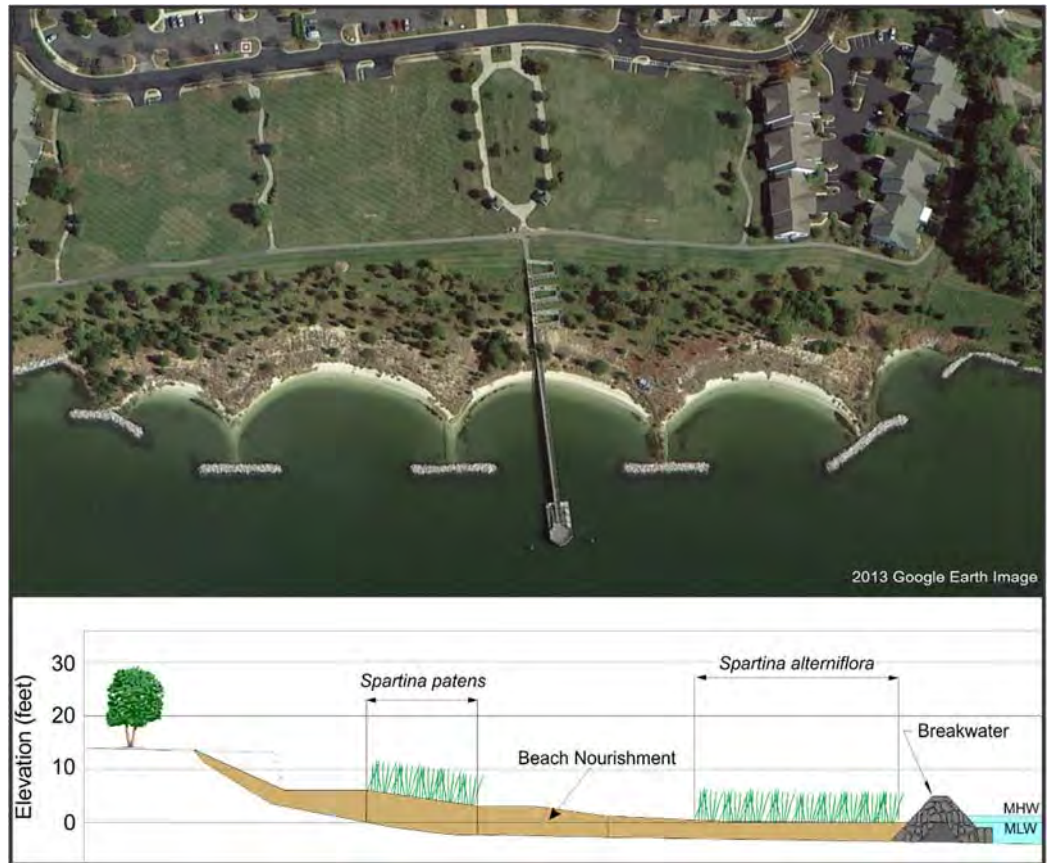
Figure 4-3. Image from Google Earth showing a breakwater installation (top) and a typical breakwater cross-section (bottom).

Attached or headland breakwaters usually require beach fill to acquire long-term shoreline erosion control (Figure 4-3) because they are generally constructed in areas that are subject to more energetic conditions. Headland breakwaters can be used to accentuate existing shore features and are the primary component for Headland Control. The dimensions of a breakwater system are dependent on the desired degree of protection and potential impacts on littoral processes.

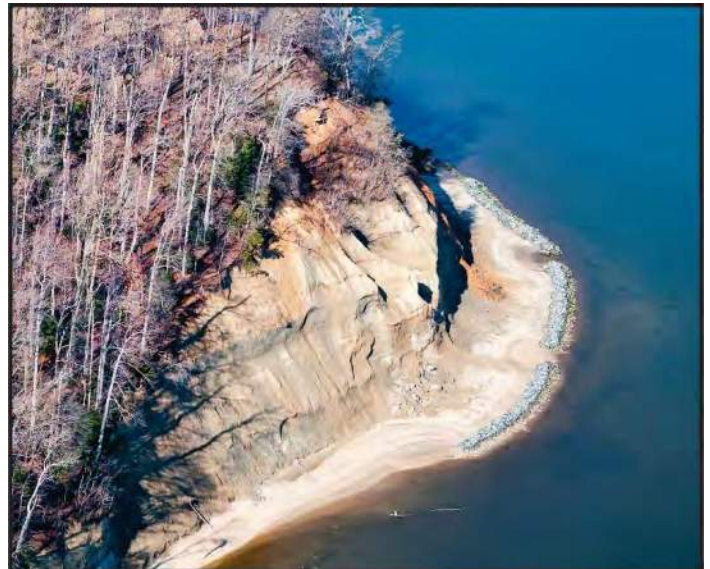
Figure 4-4. Brill system soon after construction at Westmoreland State Park in Virginia. These large structures are more continuous than breakwaters, but they are farther offshore than a sill. Eventually, the backshore will begin to vegetate.

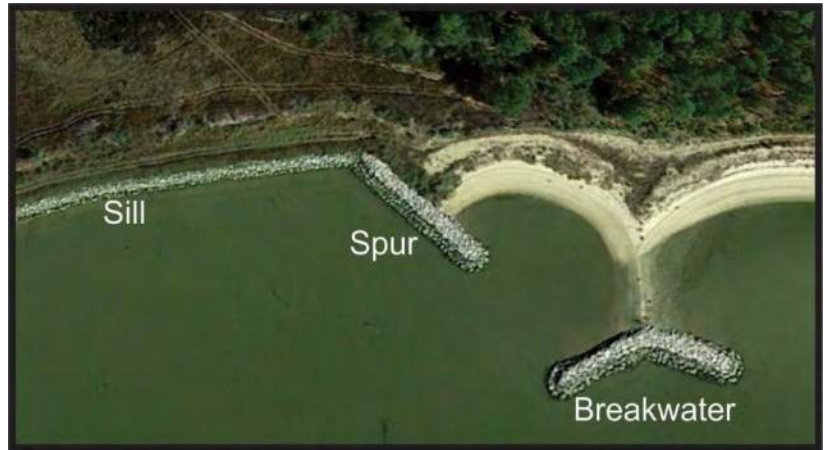
Figure 4-5. Structures at Swan Point include a breakwater, spur, and sill. The spur is attached to the mainland and protrudes at an angle. Google Earth Image.

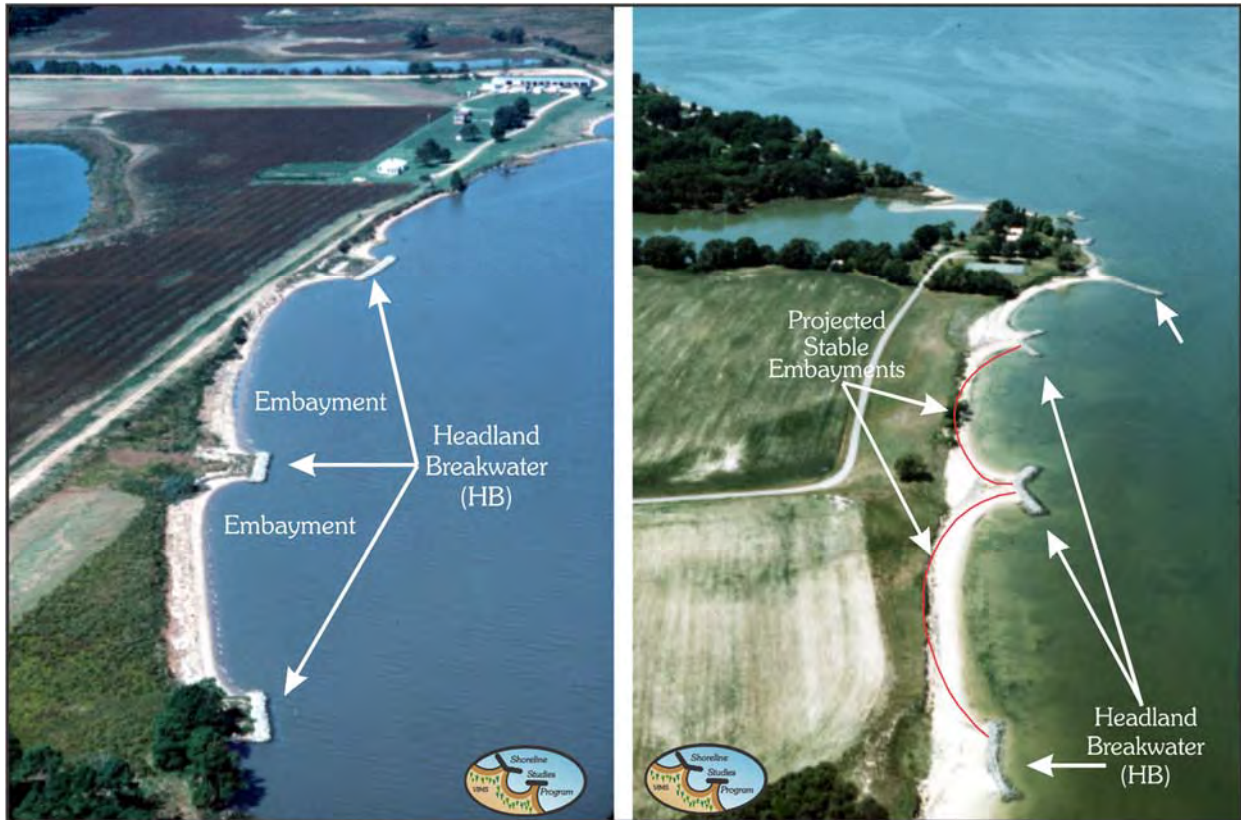
Figure 4-6. Examples of headland breakwaters spaced widely apart to allow adjacent shoreline to erode toward a dynamic equilibrium. This is a cost-effective shoreline management strategy when infrastructure is not threatened by the upland erosion between the structures. From Hardaway and Byrne (1999).

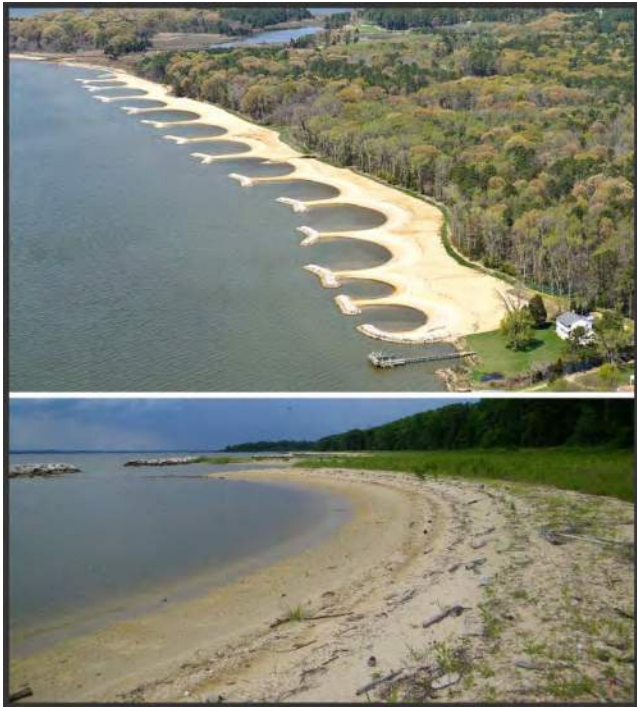
Figure 4-7. Swan Point breakwaters Top: post-construction, pre-planting, 27 March 2012; and Bottom: Four years post-construction, July 12, 2016.

Three existing projects in Charles County were designed by Coastline Design, PC that include sills and breakwaters. These include Swan Point breakwaters, Horse Farm sill, and Indian Head sill system. The Swan Point breakwater system was installed in 2010 and consists of 12 breakwaters, two spurs and a sill extending along about 1 mile of coast (Figure 4-7). Horse Farm sill system was installed in 2002 and is about 650 feet long (Figure 4-8). Both the Swan Point breakwater and Horse Farm sills have long fetch exposure so the southwest and south across and down the Potomac River of 5 to 10 miles, respectively. The Indian Head sill system was installed in phases between 2008 and 2012 totals over 3.1 miles in length with numerous gaps in the sills and intermittent bank grading (Figure 4-9). The gaps in the structures, also sometimes called windows, allow the ingress and egress of marine fauna.

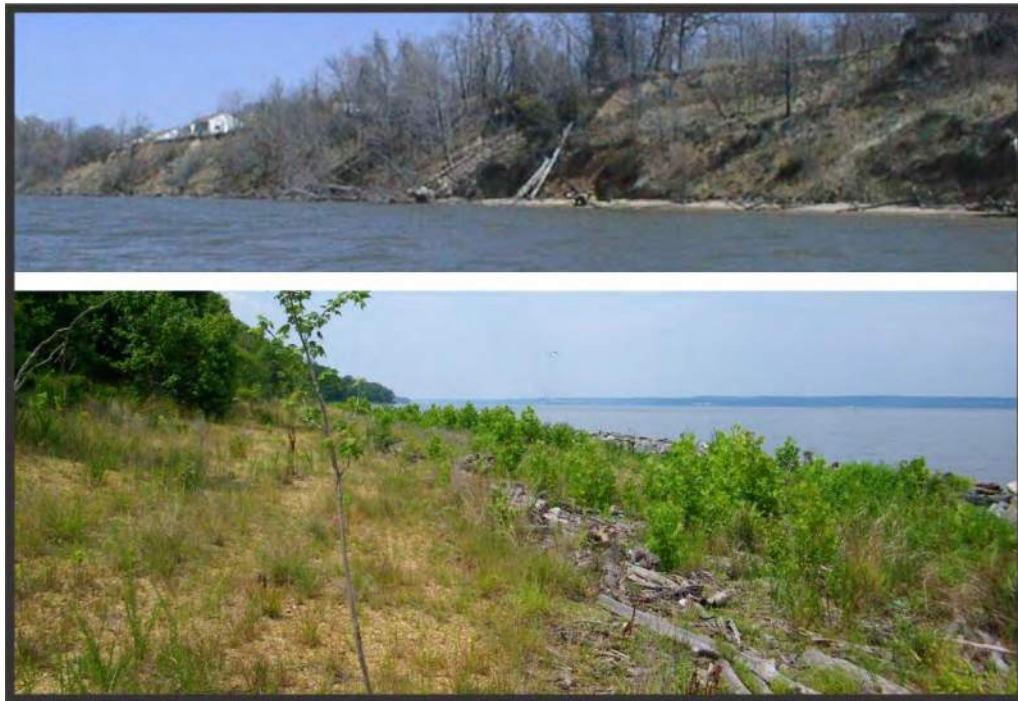
Figure 4-9. Indian Head Sill Top: Pre-construction in 2002, Bottom: 25 June 2012.

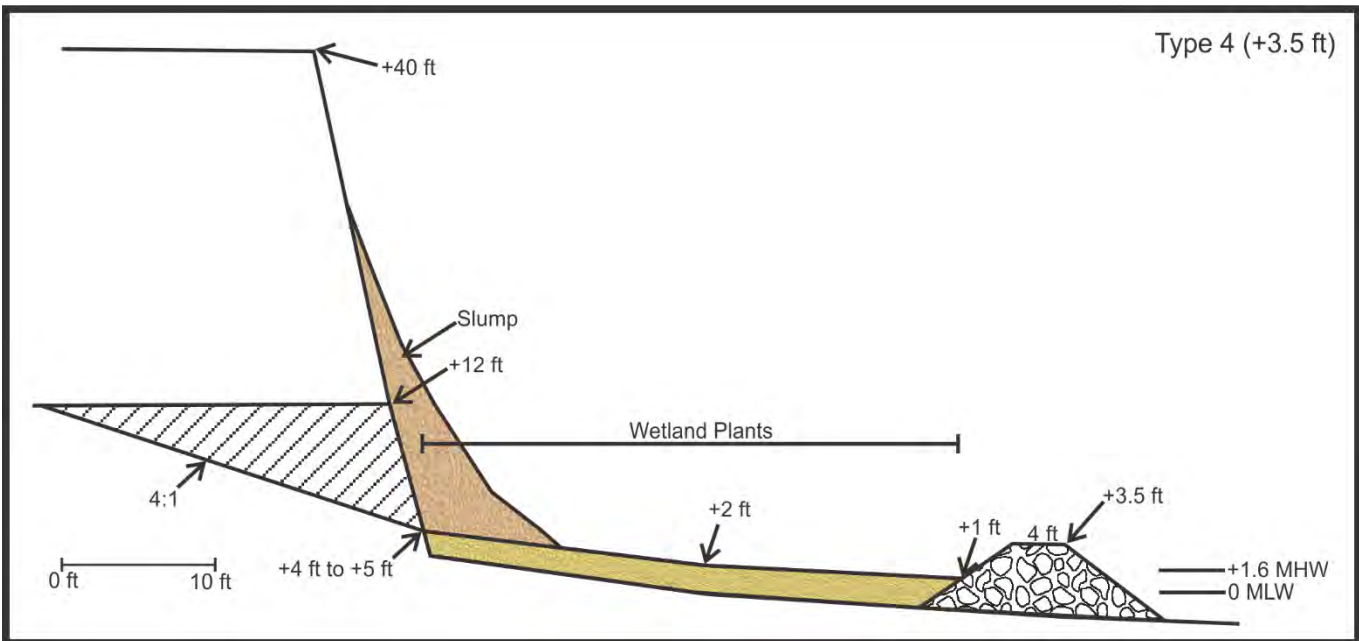
Figure 4-13. Type 4 typical sill cross-section.

How much bank grading necessary at a site is very much dependent on site-specific conditions. The 4:1 slope (or greater) is best for long term coastal resiliency, but it is only practical on lower banks, less than 12-15 feet, because typically the bank material must be handled onsite. For lower banks, the material may be used as an upland berm or elsewhere on site, and because most of the P-1s and P-2s are on agricultural land this

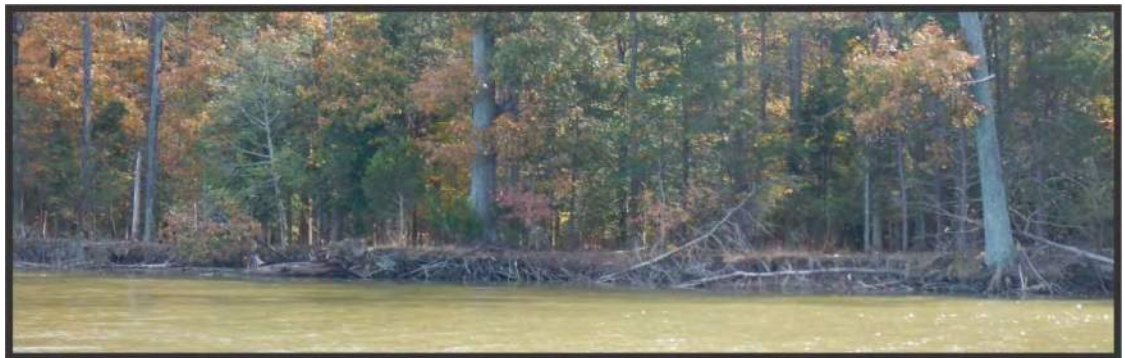
Figure 5-2. Reach 1-A – Eroding wooded upland bank, Site 2, Type 1 sill recommended.

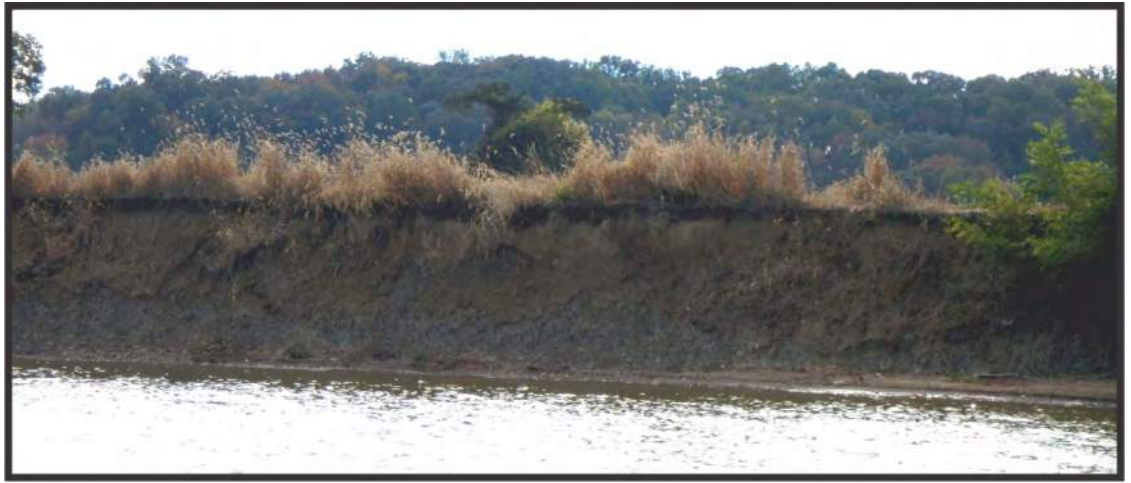
Figure 5-3. Reach 1-A – Eroding agricultural upland bank with no wooded buffer, Site 12, Type 2 sill.

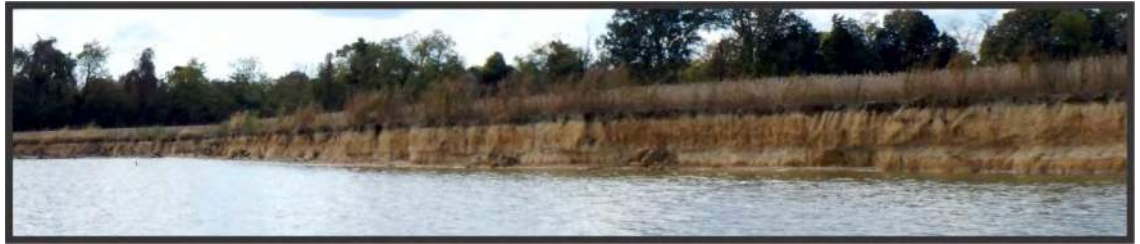
Figure 5-4. Reach 1-B – Site 23, recommend a Type 3 sill; a designated P-1 site, eroding upland, farm field with no wood buffer.

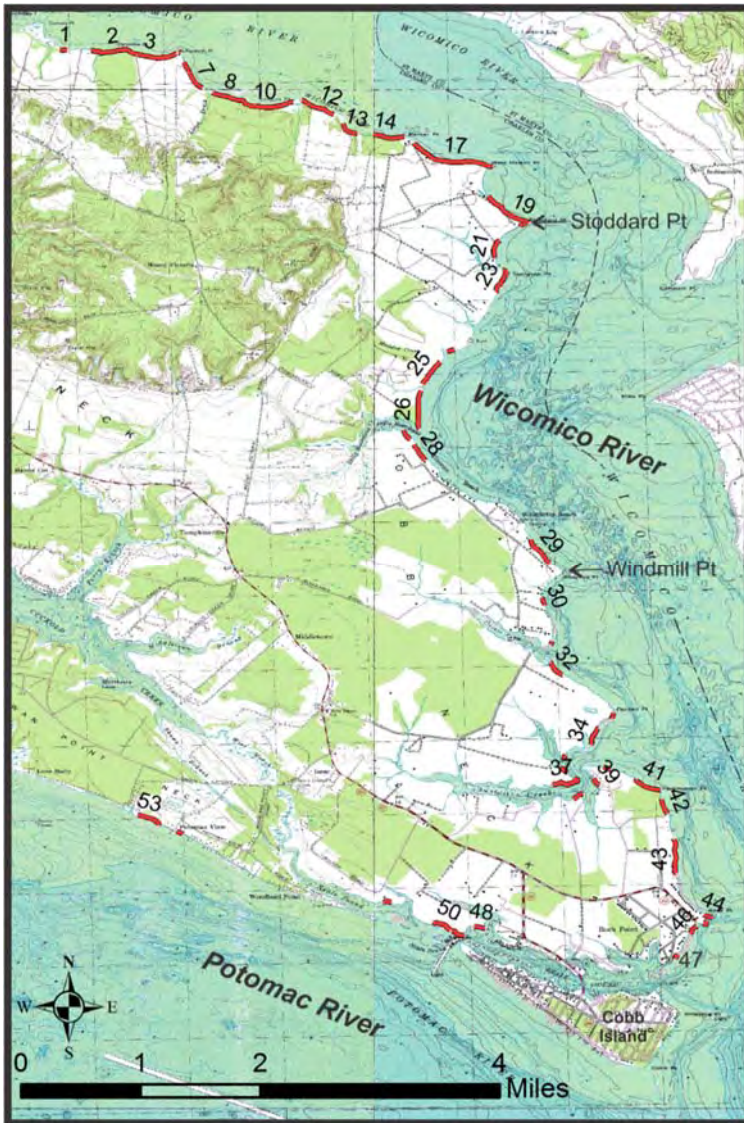
Figure 5-5. Location of site recommendations 1-47 along the Reach I coast.

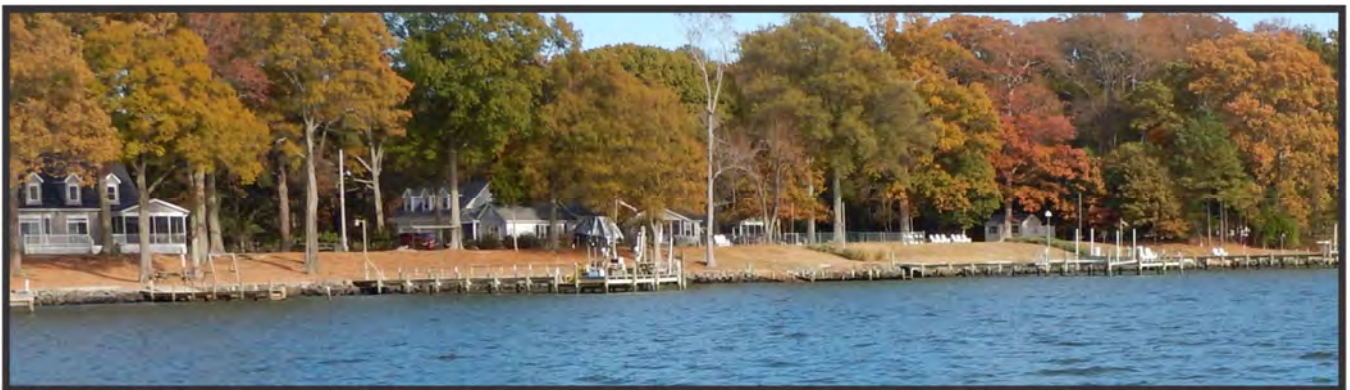
Figure 6-2. Woodland Point residential coast mostly hardened with bulkheads.

Most of the shoreline around Cobb Island is hardened. A long jetty extends from the mainland at the Neale Sound inlet channel north of Cobb Island. Low eroding, upland shorelines occur on either side of the jetty. The Woodland Point peninsula coast is mostly residential and hardened with bulkheads and riprap revetments (Figure 6-2). Farther north, an area of agricultural land at the old Horse Farm was protected by a sill system in 2002 that continues to function well (Figure 4-6). At Swan Point development, a breakwater system extends over 4,000 feet (Figure 4-5) and ends with 500 feet of low sill at the mouth of Weir Creek. A relatively stable beach resides between Weir Creek and the Swan Point spit, the boundary of Reach II-B.

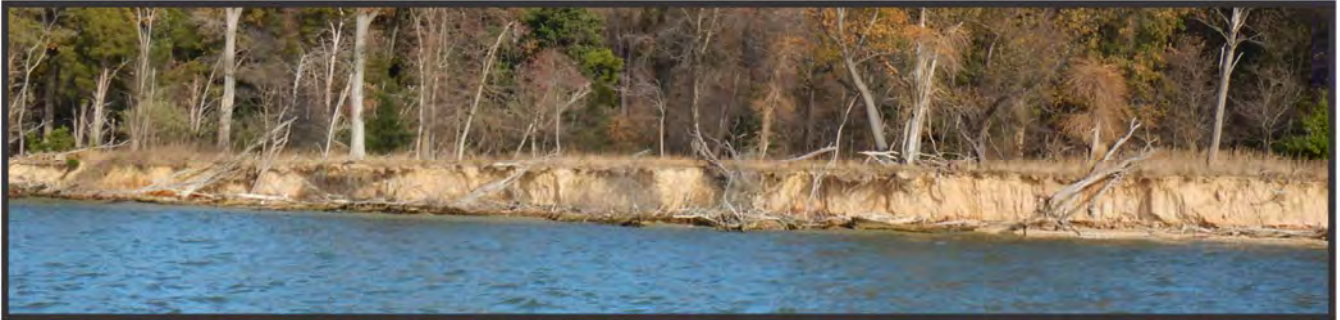
Figure 6-3. Swan Point eroding uplands, Site 54, Type 4 sill recommended.

One site was designated as P-1 sites in Reach II, site 54 (Appendix B). Due to its high erosion rate and long length, it ranked second highest of all the sites. A management strategy has previously been designed for this shoreline. Site 61 and 62 ranked as a P-2; it ranked as number 14 out of all 153 sites. Because the sites are agricultural with no wooded buffer, it is a good candidate for construction via possible barge access. A conceptual plan and cross section were developed (Figure 6-9). The total length for both sites is about 2,300 ft. Also, an old wharf existed at one time on the south side of nearby Lower Cedar Point because the deeper water comes close to the shore at this location. It could be possible to use this as an access point for a barge to bring rock ashore and transfer to trucks.

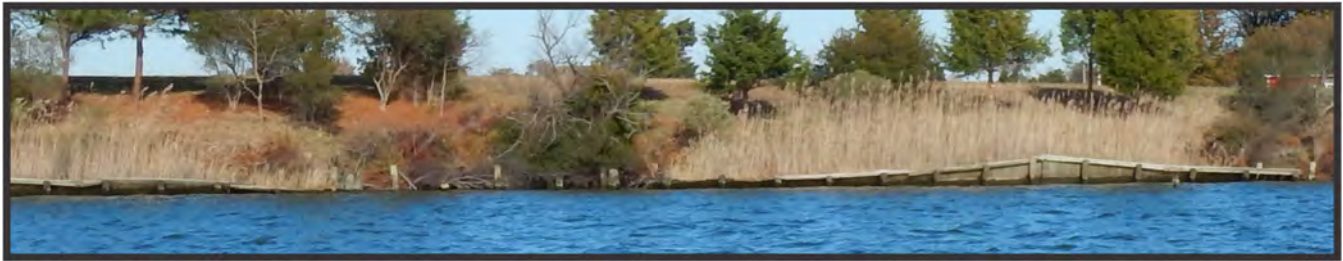
Figure 6-4. Failing bulkhead, Site 55, recommend replace with Type 4 sill.

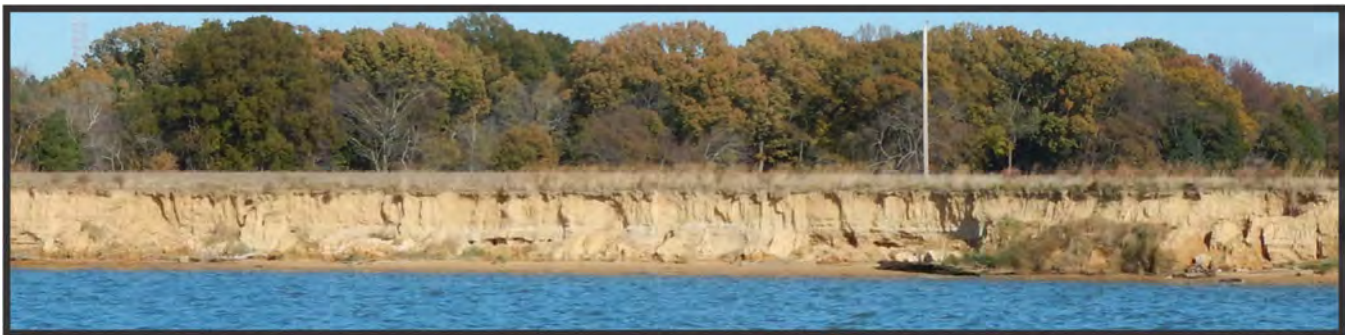
Figure 6-5. Eroding agricultural upland, Site 61, designated P-2 and recommend Type 5 sill.

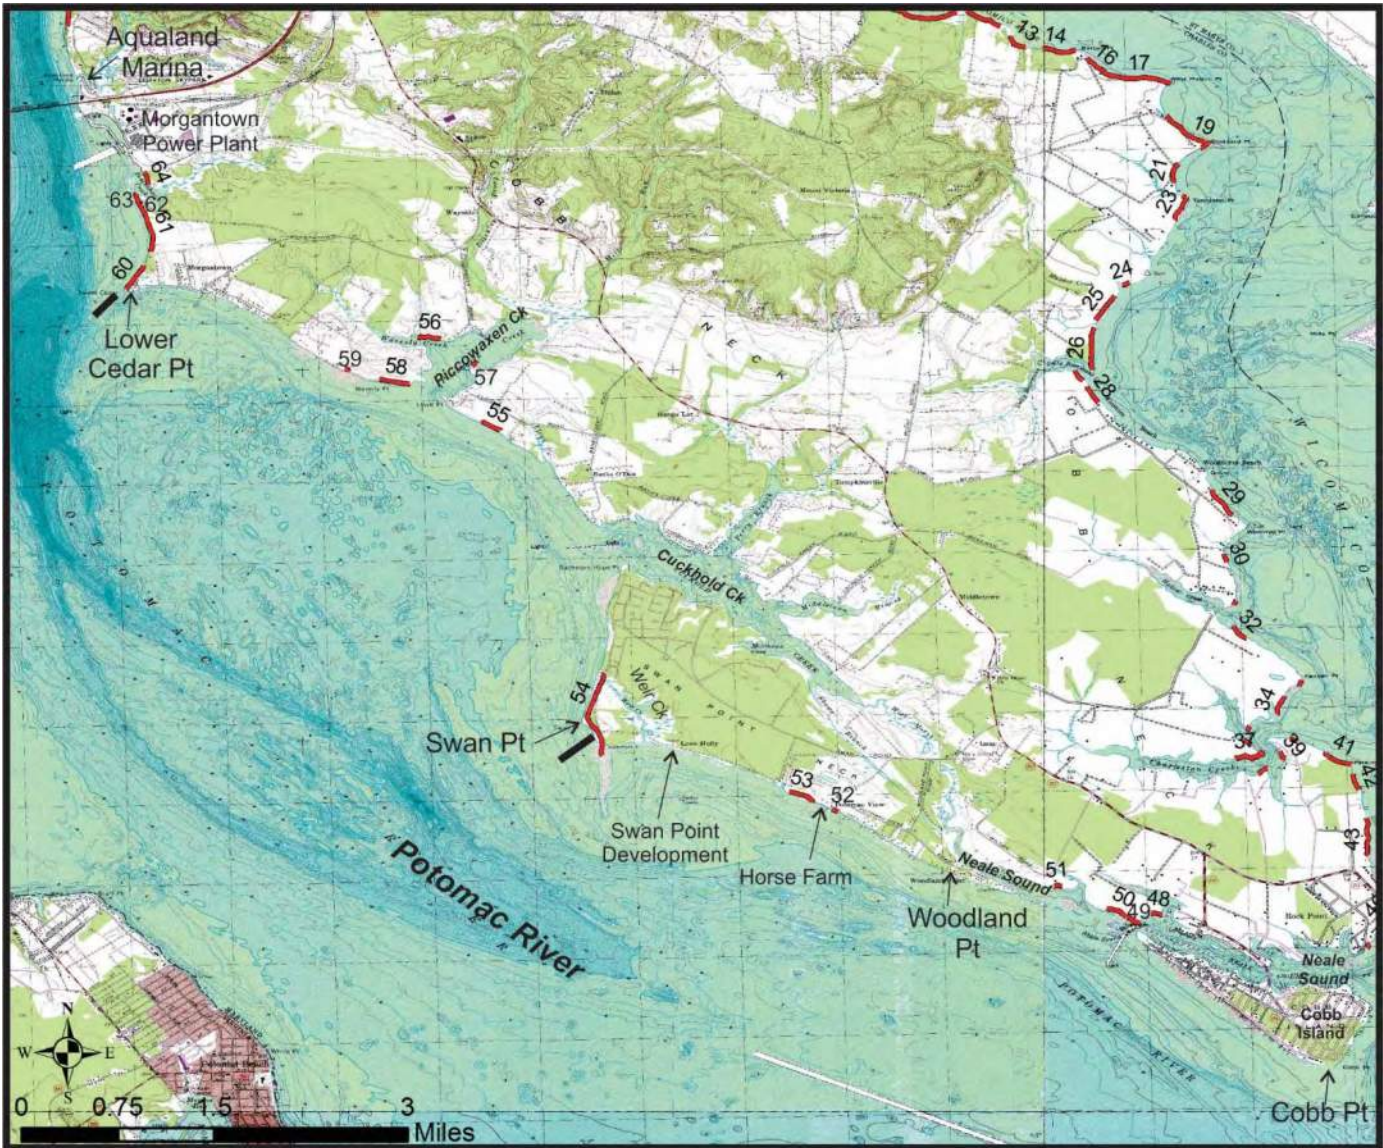
Figure 6-7. Reach II recommended site locations 48-64.

Seventeen site recommendations were made along Reach II totaling 2.6 miles (Figure 6-7). These are the options for Reach II:

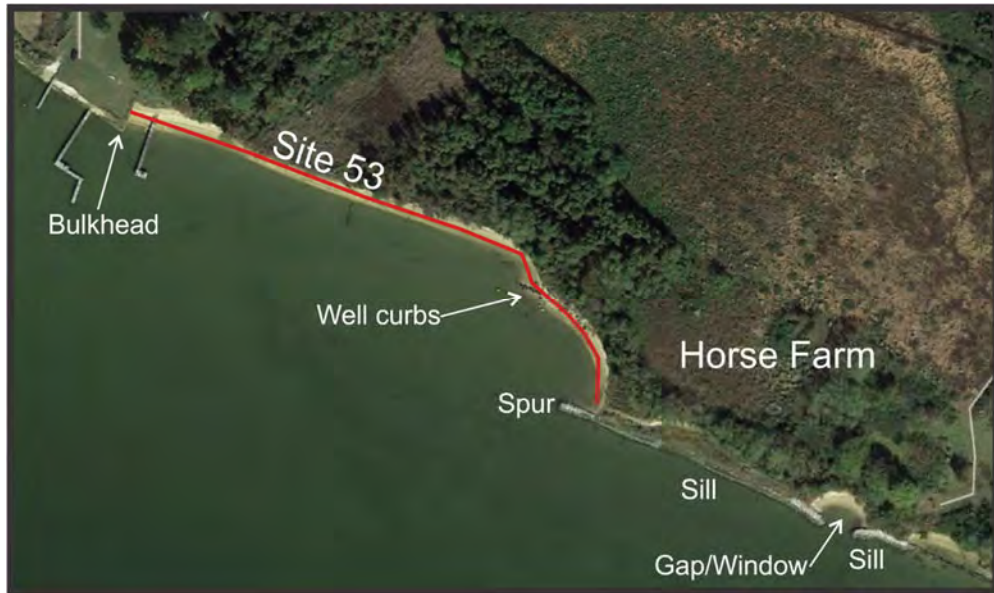
Figure 6-8. Horse Farm shore protection consists of two sills and a spur. The spur and the upriver bulkhead can be considered headlands that define an embayment along the shoreline which will erode to a dynamically stable planform over time.

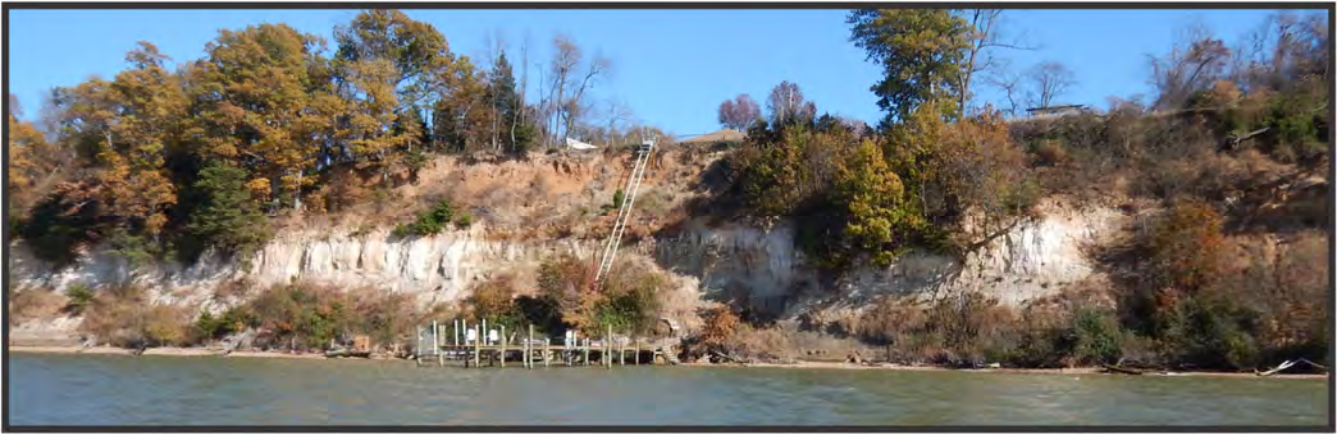
Figure 7-2. High eroding upland bluffs along Clifton, Site 66, recommend Type 5 sill.

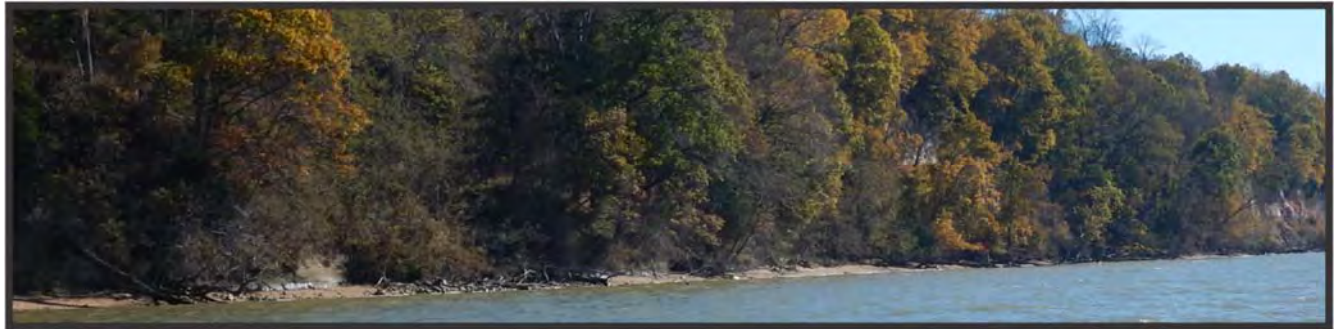
Figure 7-4. Eroding high upland bluffs with intermittent slumps. Site 73, recommend a Type 4 sill.

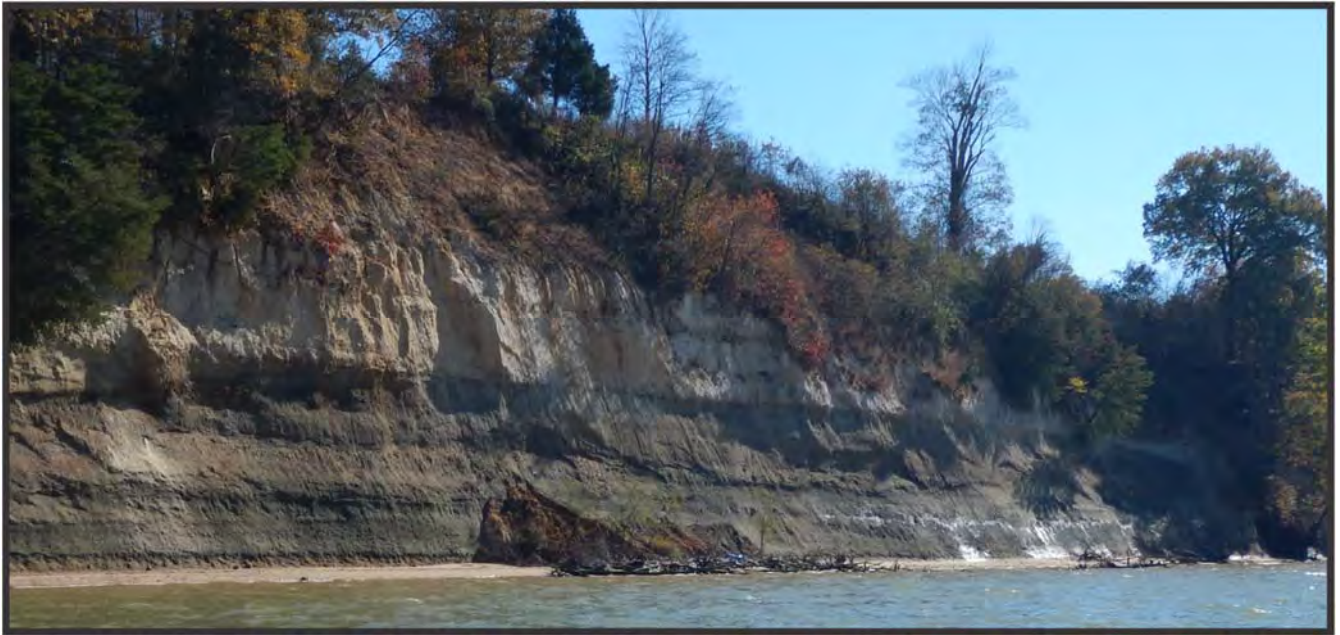
Figure 7-5. High upland bluffs with erosional BOB and bank face with residential land use. Site 76, recommend Type 5 sill.

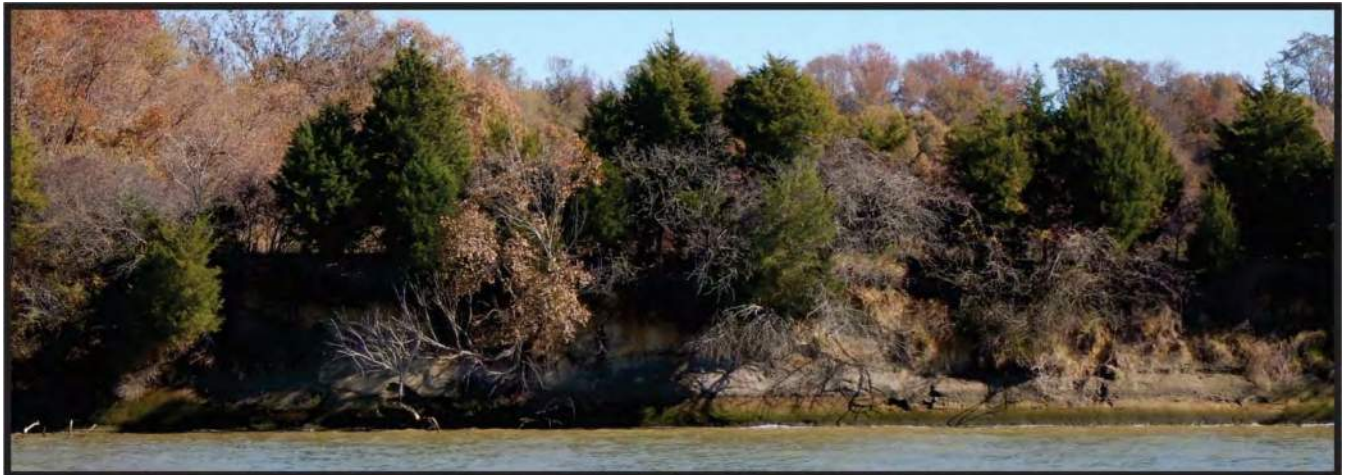
Figure 7-6. Eroding low upland banks, Site 81, designated P-1, use Type 5 sill.

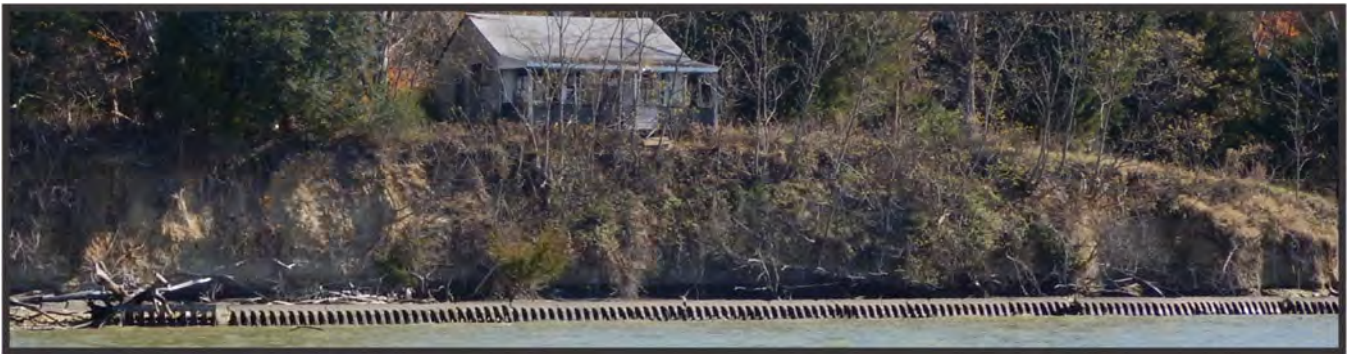
Figure 7-8. Beach prisms along the shoreline are not effective at shore protection.

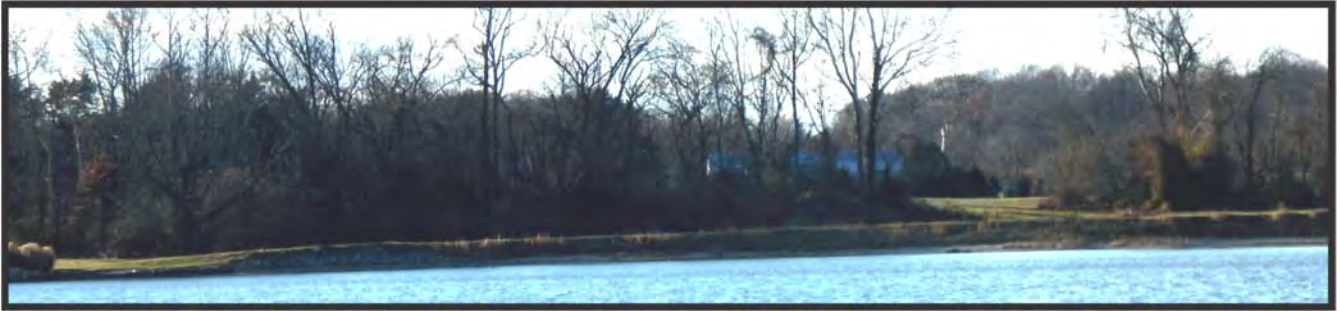
Figure 7-10. West side of Tobacco River with very low eroding agricultural banks, Site 92, recommend Type 3 sill.

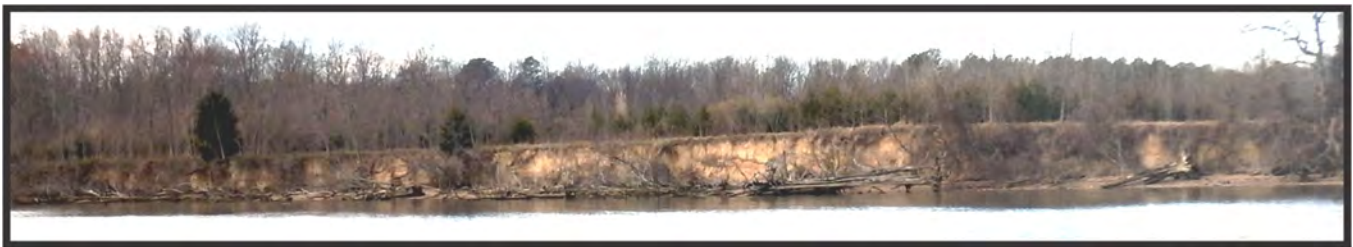
Figure 8-2. Eroding low agricultural upland bank, Site 96, ranked as a P-2, recommend Type 5 sill.

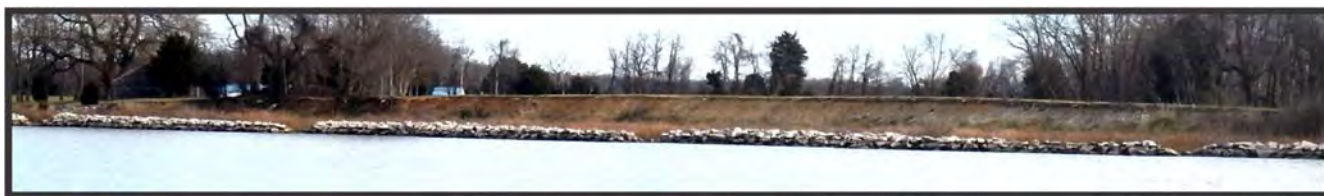
Figure 8-3. Along Nanjemoy Creek, a low upland bank protected by a gapped sill system exists, but the bank was not graded. This type of system is comparable to a Type 4 sill system.

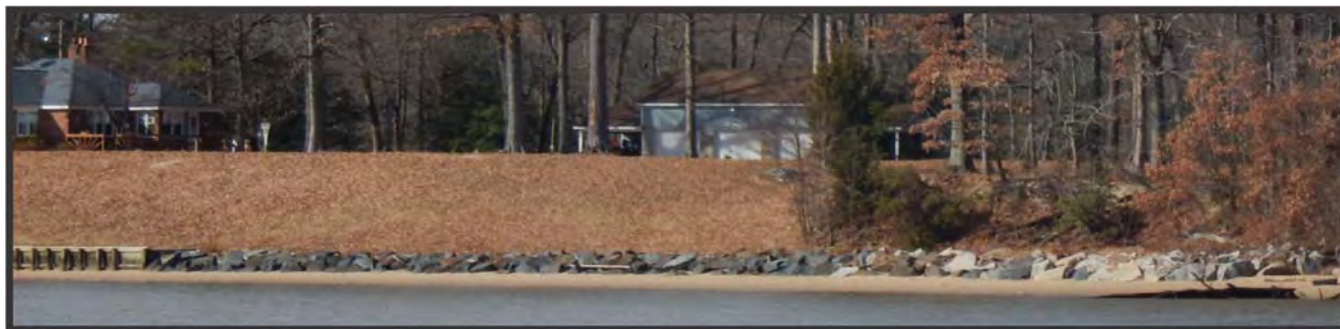
Figure 8-4. Typical hardened shoreline along Reach IV-C.

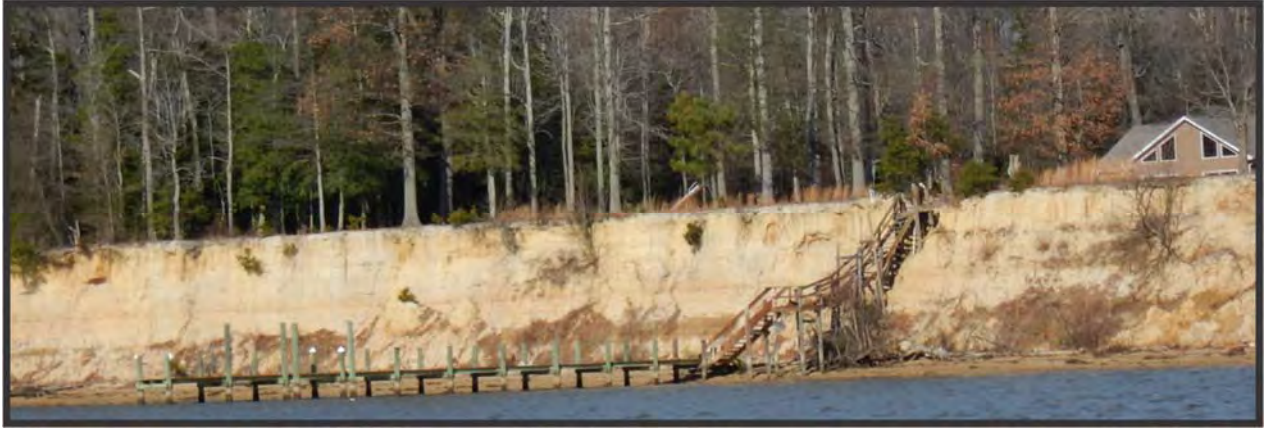
*Figure 9-2. Vertically exposed eroding upland bank on residential property along Reach VA, Site 115, recommend Type 5 sill.*

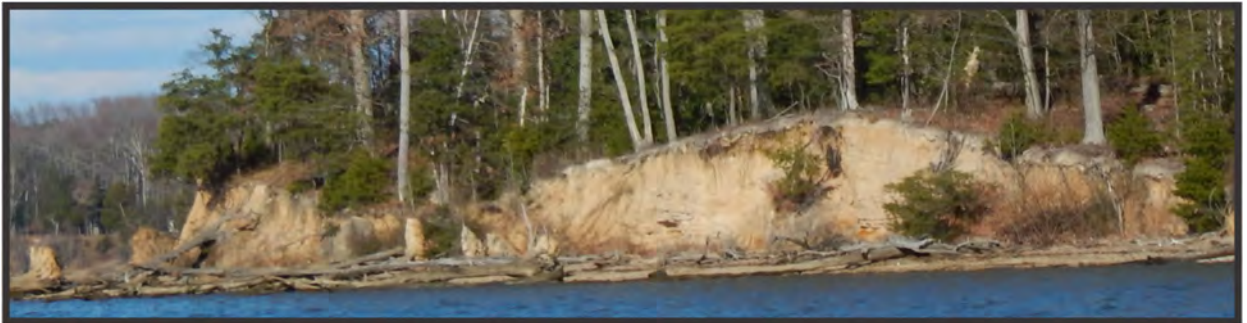
*Figure 9-4. Eroding headland at Douglas Point, Site 123, recommend a Type 4 sill.*

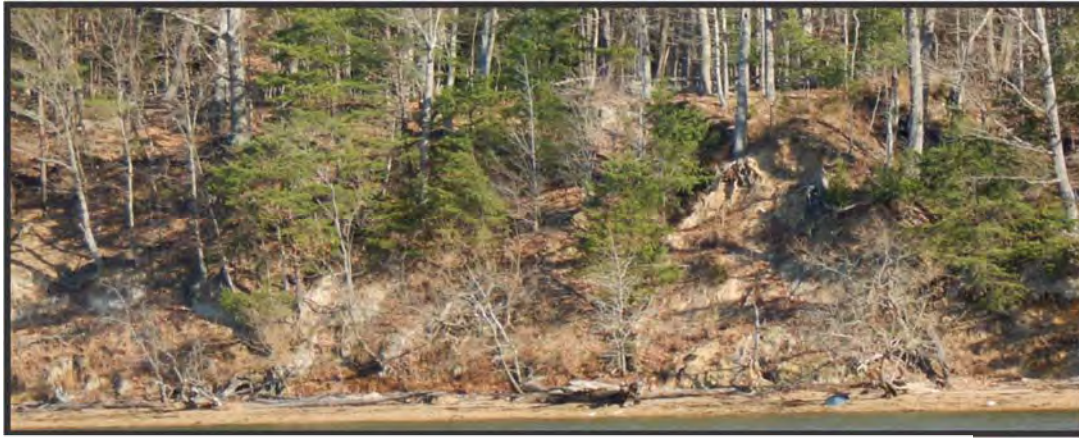
Figure 9-6. Slumps with trees along upland bank just upriver from Sandy Point.

Reach V-C extends from Sandy Point northward, and the shoreline continues as eroding upland banks, increasing in elevation. These areas are heavily wooded. Banks slumps are common as large trees slide into the river (Figure 9-6). The Stump Neck coast is on Indian Head Naval Base which already has a Shoreline Management Plan developed for the base in 2002 by Coastline Design, PC. Much of the plan was implemented in several phases.

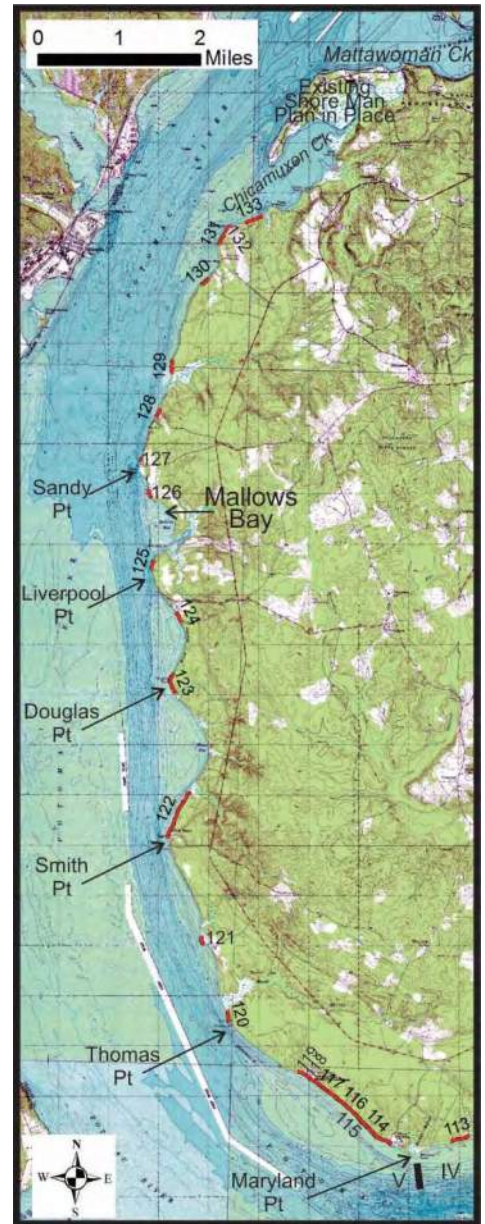
Figure 9-7. Reach V site recommendation locations.

A total of 20 sites were given recommendations along 4.1 miles of shoreline for Reach V (Figure 9-7) as shown in Appendix A. No sites are P-1. These are the options for Reach V:

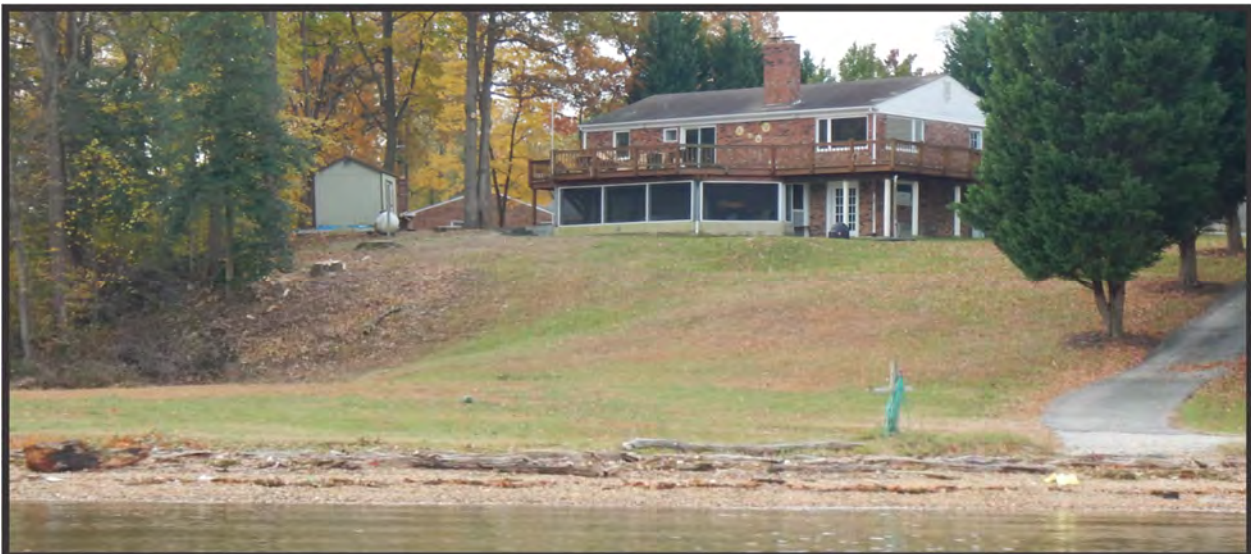
*Figure 10-3. Graded banks with a wide backshore can work along some segments of Reach VI-B.*

Reach VI-A includes the coast of Indian Head up to upriver boundary of the Base where reach VI-B begins. Here the banks have erosional to transitional BOBs and bank face and vegetated slumps fronting residential properties with occasional bank grading and hardening (Figure 10-2 and 10-3). When the upland banks are cleared of trees and the grade is toward the river, active erosion from the top down can ensue (Figure 10-4). This reach has a deep nearshore, which can allow for transport of construction materials by barge. However, the deep nearshore restricts the width of the sill system such that only high marsh may exist, or a

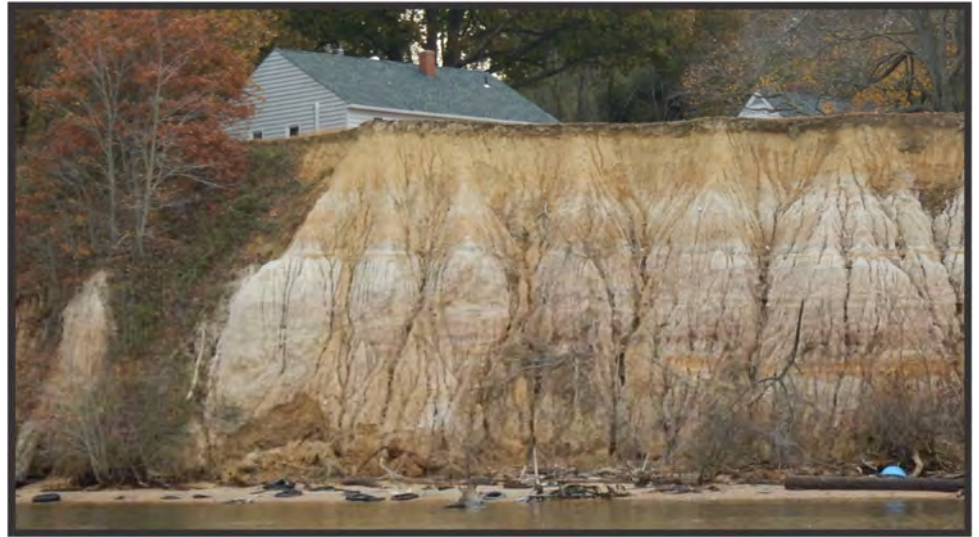
*Figure 10-4. Eroding high bank with upland runoff problems as evidenced by gullies running down the bank. Site 144, Type 5 sill, bank grading recommended. Nearshore is deep and may restrict options to shoreline defense, like a revetment.*

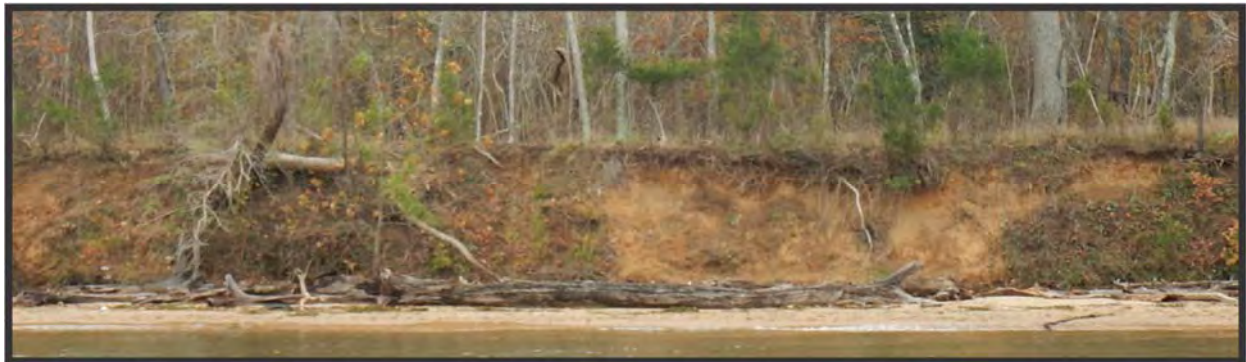
*Figure 10-5. Low eroding uplands north of Chapman Point.*

revetment may be needed. The uplands in Reach VI-B transition from residential to wide wooded banks. The high banks (+100 ft) decrease to 10-20 ft toward the north. The shoreline from Chapman Point north are alternating eroding banks (Figure 10-5) and intersecting low drainages or marshes (Figure 10-6).
