**FINAL**  
**ASSESSMENT AND**  
**SHORELINE MANAGEMENT PLAN**  
**FOR REACHING NPDES MUNICIPAL SEPARATE STORM**  
**SEWER SYSTEM PERMIT (MS4) GOALS**  
**FOR**  
**CHARLES COUNTY, MARYLAND**

**September 2018**

SOUTHERN MARYLAND  
RESOURCE CONSERVATION AND DEVELOPMENT  
(RC&D)

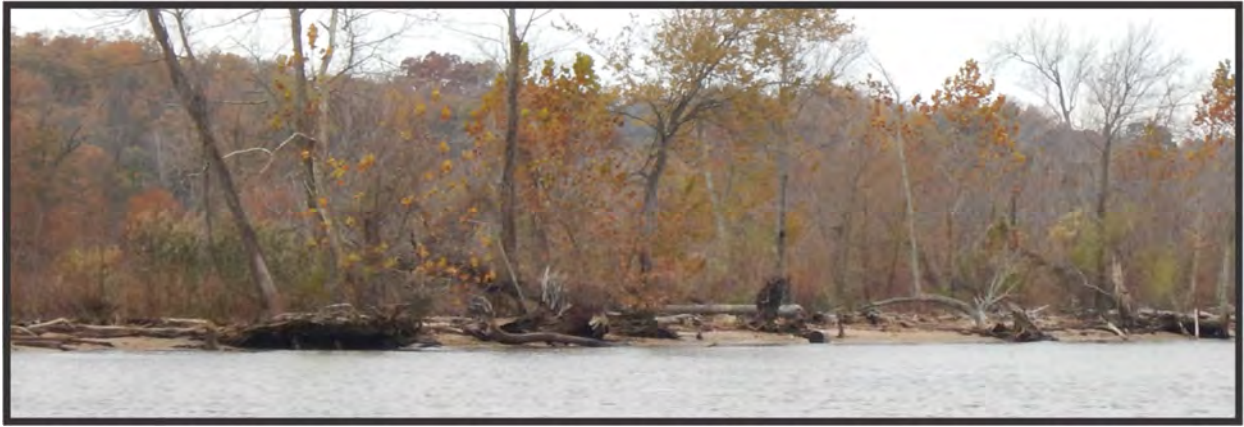
Figure 10-6. Intersecting low drainages along the Reach VI-B coast.

revetment may be needed. The uplands in Reach VI-B transition from residential to wide wooded banks. The high banks (+100 ft) decrease to 10-20 ft toward the north. The shoreline from Chapman Point north are alternating eroding banks (Figure 10-5) and intersecting low drainages or marshes (Figure 10-6).

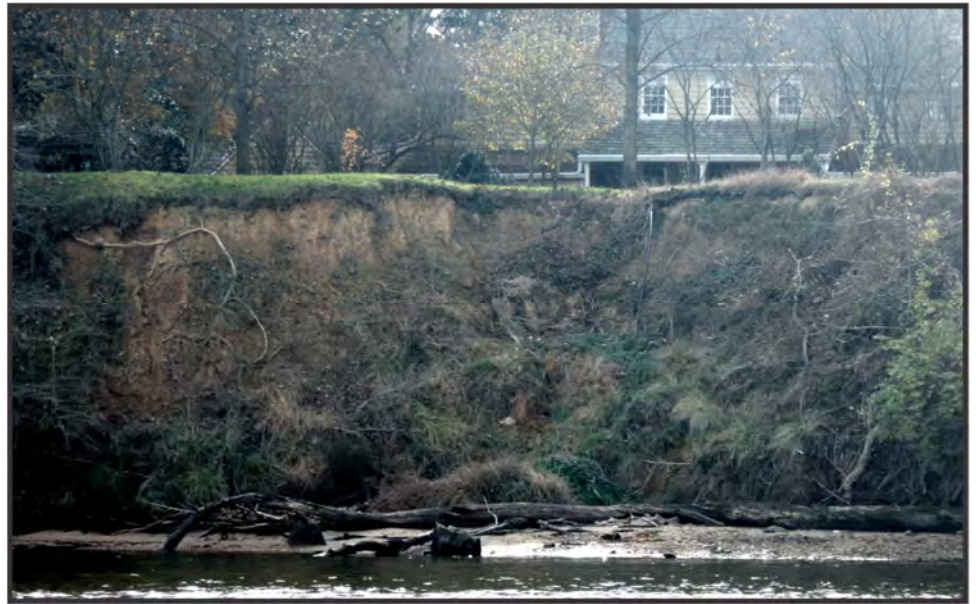
Figure 10-8. Eroding upland near the upriver boundary of Reach VI-C. It is the location of Site 157. Nearshore sill or revetment is recommended due to deep nearshore and historical presence of SAV.

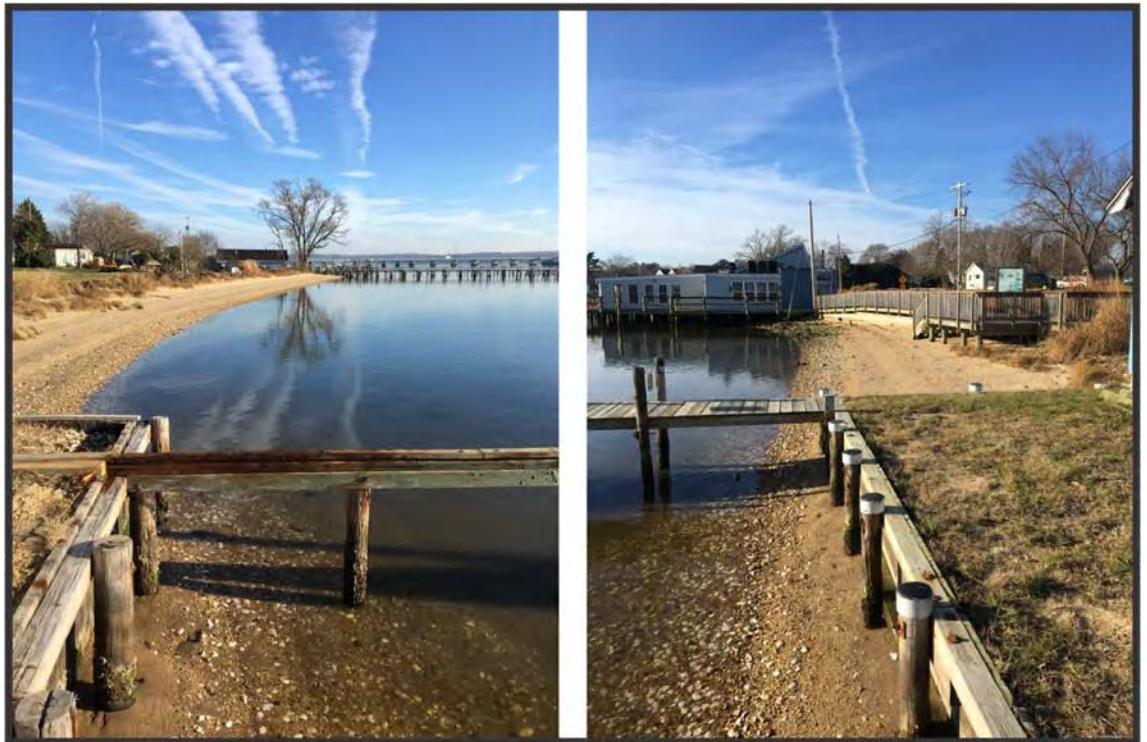
Figure 11-2. Town of Benedict shoreline that is mostly hardened which form some headlands with pocket beaches in between.

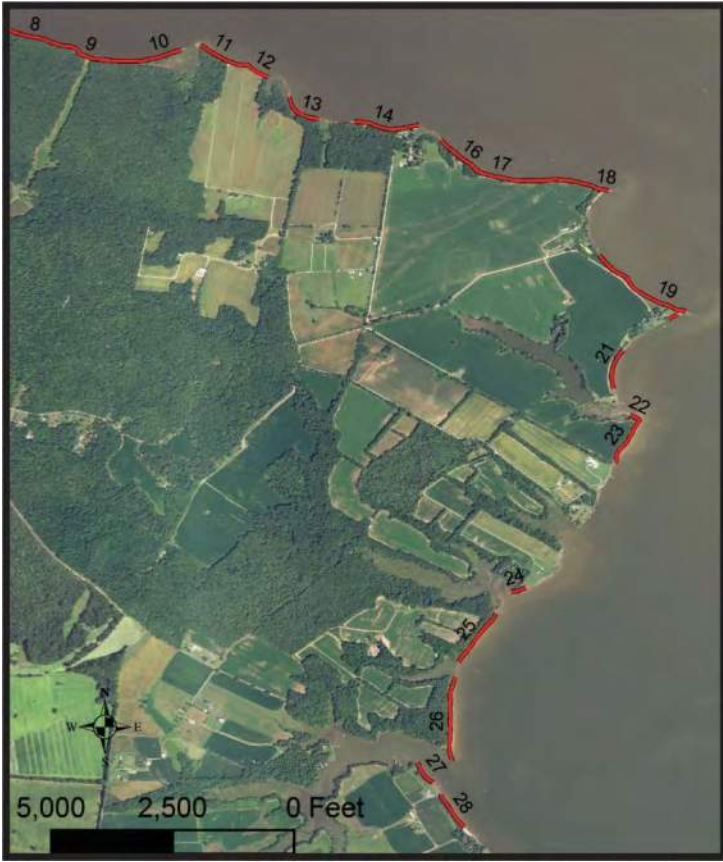
Figure 12-1. Reach I, site recommendations 8 thru 28.

Reach I along the Wicomico River, has sites which are all relatively close to each other. All land access must come down Cobb Neck via Route 257, Newburg Road. Figure 12-1 shows sites 8 thru 28. Site 23 is a P-1. Grouping P-1s and P-2s during construction would be cost effective shoreline management planning in this case. Grouping two or more sites will require multiple landowner permissions and concurrent design and permitting of those selected sites so the permits for all sites are timely. Bidding for multiple projects also could be done simultaneously, which also saves time and money.

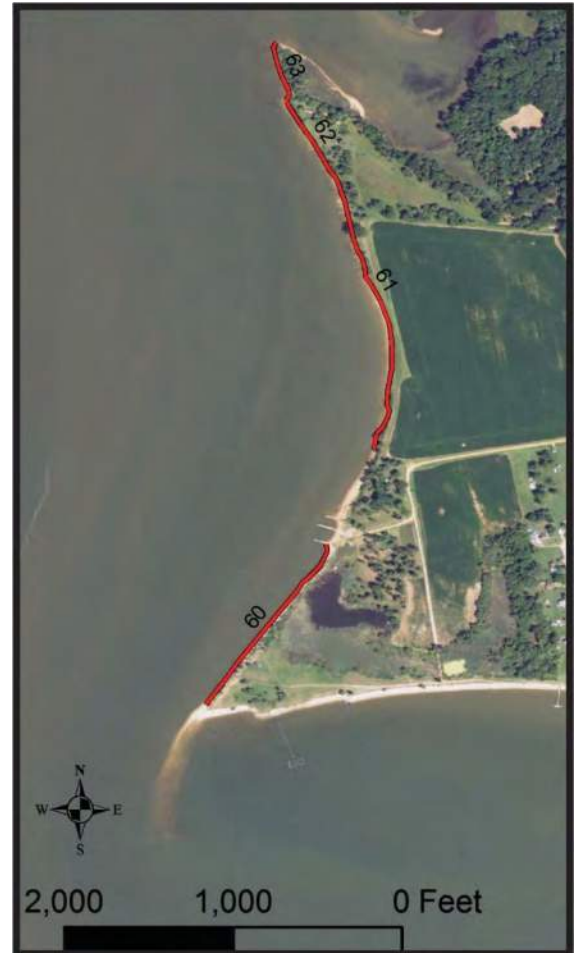
Figure 12-2. Reach II, example of combining Sites 61 and 62 for cost effective design permitting and construction.

In Reach II, sites 61 and 62, make an obvious combination project location (Figure 12-2). They could be built from land with material brought in by both land and barge. An old wharf occurs on the side of Lower Cedar Point where rock could be brought in via a barge port and transferred the short distance to the sites by large site trucks (Figure 12-3). Sand would probably come in from land.

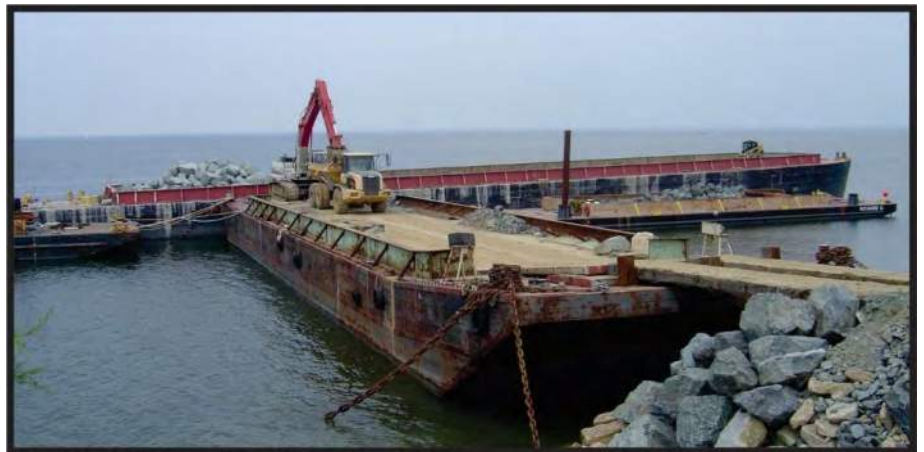
Figure 12-3. Materials being brought to the site by barge.

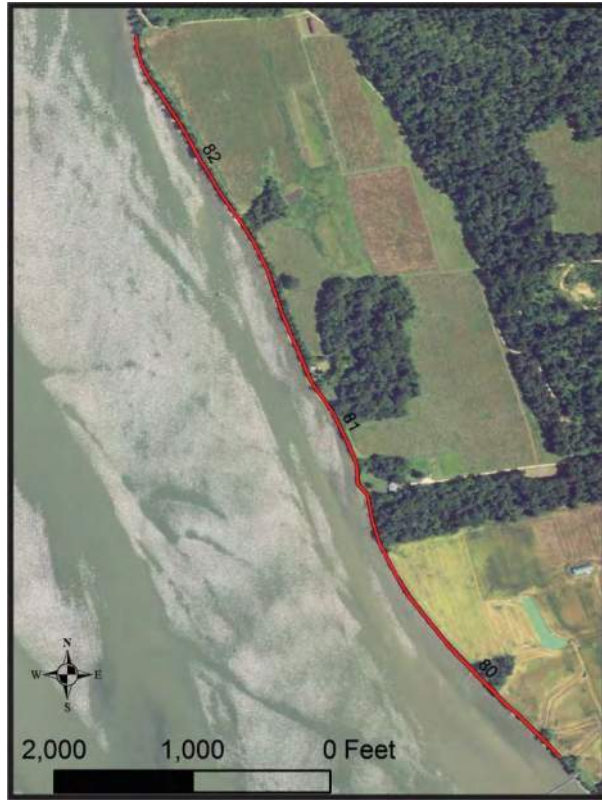
Figure 12-4. Reach III. Combining Sites 80, 81, and 82 for cost effective design, permitting and construction.

Reach III, sites 80, 81, and 82, are essentially adjacent to each other and tentatively buildable or at least accessed by barge (Figure 12-4). No bank grading would occur.

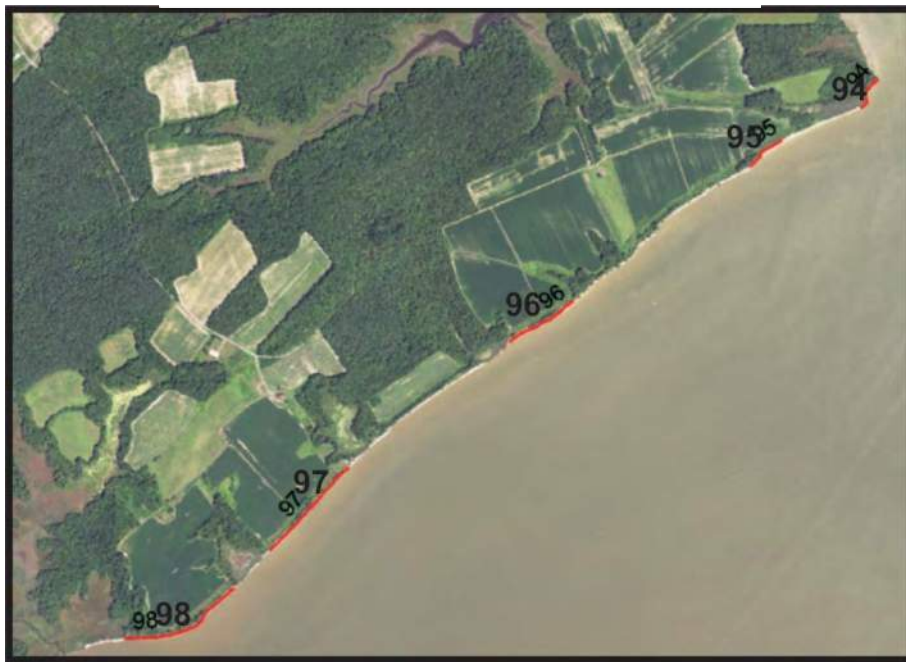
Figure 12-5. Reach IV. Combining Sites 95, 96, 97, and 98 for cost effective design, permitting and construction.

In Reach IV, sites 94, 95, 96, 97, and 98 are all located on Cedar Point Wildlife Management Area with one main access road that branches off to secondary accesses to the sites (Figure 12-5). All these sites appear to have either narrow wooded riparian buffers or grass buffers on the upland so bank grading could occur to enhance coastal resiliency. Construction still requires access through these buffers, so temporary impact to the grass buffers is preferred because they are more easily restored.
